Technical Service Bulletin

91 Night vision system inoperative, DTC B201000 stored in night vision control module

91 18 04 2045020/3 July 17, 2018. Supersedes Technical Service Bulletin Group 91 number 18-85 dated March 8, 2018 for reasons listed below.

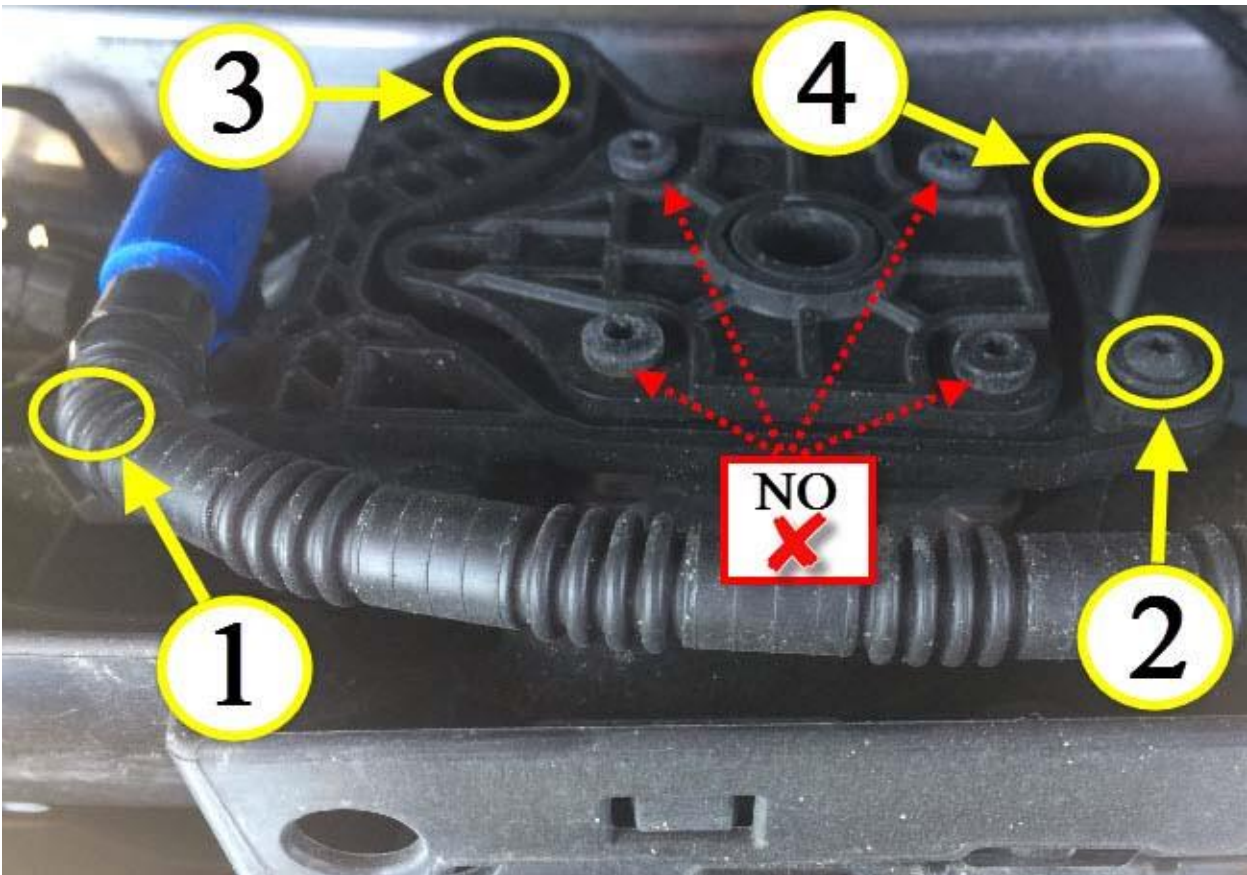
Figure 1. Night Vision Camera Mounting Bracket Screw Retainer Locations 1, 2, 3, and 4. Loosen screws 1, 2, 3, and 4. Do not remove or loosen the four screws holding the camera to the bracket.

6. Loosen the night vision camera mounting bracket by loosening the four mounting screws that hold the mounting bracket to the radiator grill. Mounting screws are shown in the image below (Figure 1) by numbered arrows 1, 2, 3, and 4. Do not remove or loosen the four screws that hold the camera onto the camera mounting bracket, these are shown in the image with red dotted arrows.

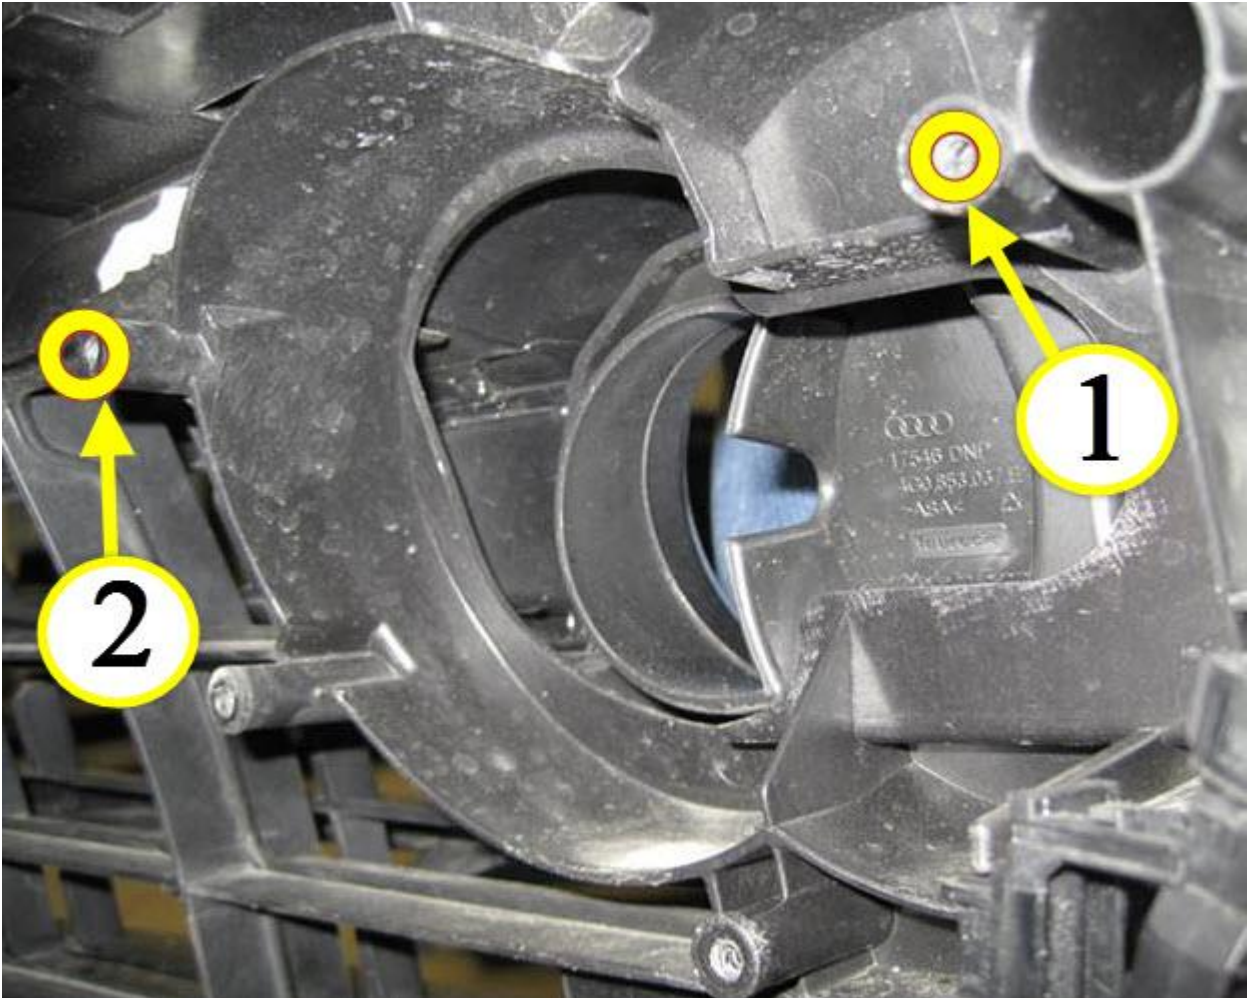
Figure 2. Radiator grill screw retainer locations with camera removed for reference. Spacer (N01152322) will be placed at locations 1 and 2.

7. Place a single spacer, part number N01152322, between each of the two upper mounting points that secure the night vision camera bracket to the radiator grill. These screws are shown in the above image as points 1 and 2 (Figure 1). The image below (Figure 2) references these points on the radiator grill as 1 and 2. The next image (Figure 3) shows placement of the spacer on the camera as points 1 and 2, the camera has been removed for clarity.

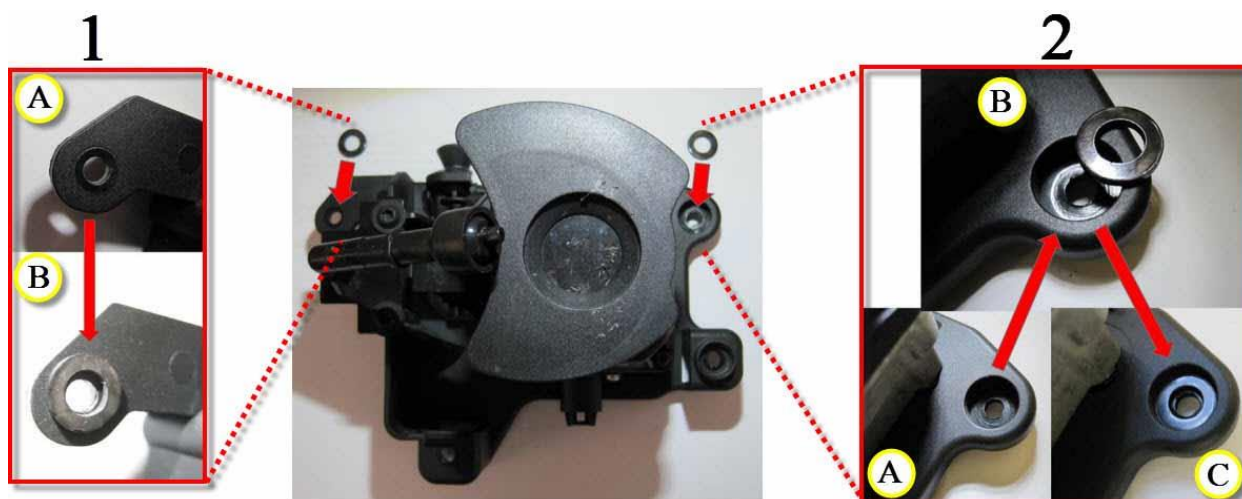
Figure 3. Additional photo showing spacer placement with the camera removed for reference. Place spacer on the grill facing side of the camera's upper mounting surface in positions 1 and 2.

8. After positioning the two spacers between the night vision cameras upper mount points and the radiator grill, torque all four screws to 2.5Nm.
9. Perform the calibration of the night vision system once again. Following the calibration, the new final pitch angles displayed by the tester should be between 0.3° and 1° less than the original values recorded. A final pitch value between +0.5° and +1.1° is acceptable.
10. If this is an RS 7 model, additional systems must also be calibrated due to removal of the front bumper. Consult the Elsa repair manual for these procedures.
