Technical Service Bulletin

42H6 UPDATE – Checking Right Rear Tie Rod Bolted Connection (NVLW)

July 17, 2018

Model(s)	Year	VIN Range	Vehicle-Specific Equipment
A6 Sedan, S6, A7, S7, RS7	2016	See Campaign/Action screen in Elsa	See Campaign/Action screen in Elsa

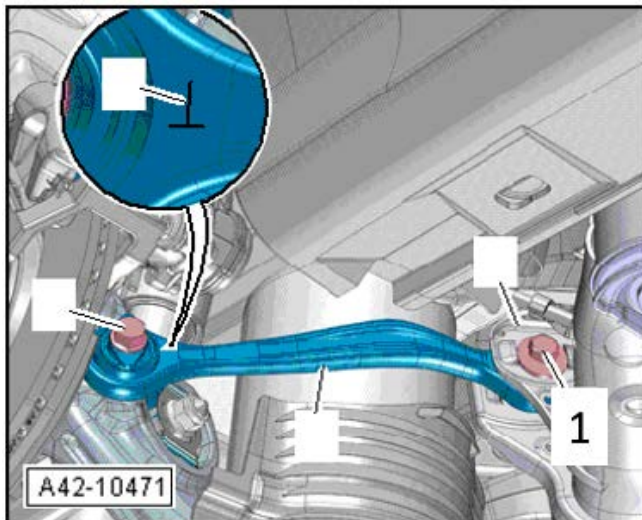
On Audi A6 and A7 vehicles manufactured within a specific period, the bolted connection for the tie rod (rear right) may not have been tightened correctly. This was due to a fault with the production's screwing system.

- Check torque of bolted connection <1>:
 - **Eccentric bolt <1> must not be turned.**
 - Torque wrench must be placed on the nut for bolt <1>.
 - Set torque wrench to 76 Nm, counterhold bolt <1> and apply torque on nut.
- If the nut turns before 76 Nm is achieved, the bolt, nut and washer must be replaced.
- If the nut can be torqued to 76 Nm without moving, no further work is required.
