SUBJECT: **SPECIAL POLICY ADJUSTMENT FOR 1988 – EARLY 1990 TRUCK &
4RUNNER WITH 3VZ-E V6 ENGINES
AND
SPECIAL SERVICE CAMPAIGN (V06) FOR 1990 – EARLY 1995 TRUCK,
4RUNNER & T100 WITH 3VZ-E V6 ENGINES**

3VZ-E Head Gasket Special Policy Adjustment

3VZ-E Head Gasket Special Service Campaign (V06)

3VZ-E SPA/SSC—V06

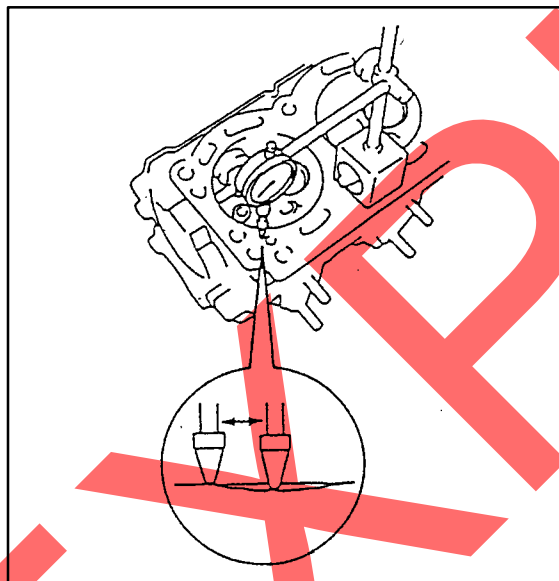
3. MEASURE CYLINDER BLOCK CONTACT SURFACES FOR DEPTH OF EROSION.

- (a). Using a dial indicator, measure the depth of erosion of the surfaces contacting the cylinder head gasket.

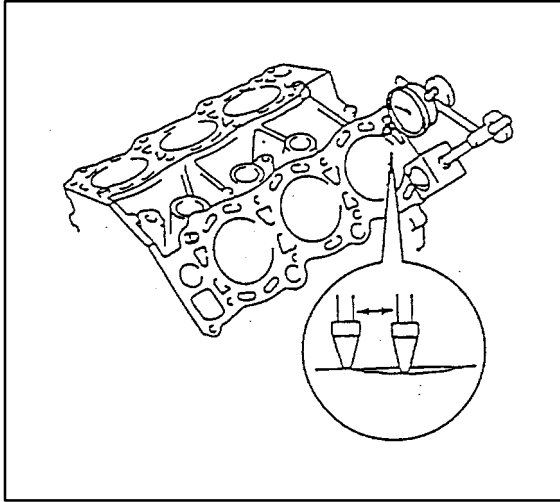
3. MEASURE TOP SURFACE OF CYLINDER BLOCK FOR EROSION.

BLOCK MEASUREMENT		
Less than 0.05 mm (0.002 in)	More than 0.05 mm (0.002 in) but less than 0.25 mm (0.010 in)	More than 0.25 mm (0.010 in)
Block may be reused without machining	*Block may be machined to a maximum of 0.25 mm (0.010 in)	Replace short block assembly

- (a). Using a dial indicator, measure the depth of erosion of the surfaces contacting the cylinder head gasket.

***NOTE: WHEN MACHINING CYLINDER HEAD AND BLOCK THE COMBINED AMOUNT OF MATERIAL REMOVED MUST NOT EXCEED 0.25 mm (0.010 in).**

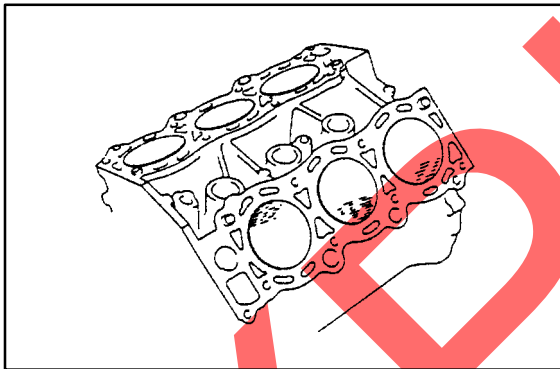
1. INSPECT CYLINDERS FOR VERTICAL SCRATCHES

- (a). Visually check the cylinders for vertical scratches. If deep scratches are present, replace the short block assembly.

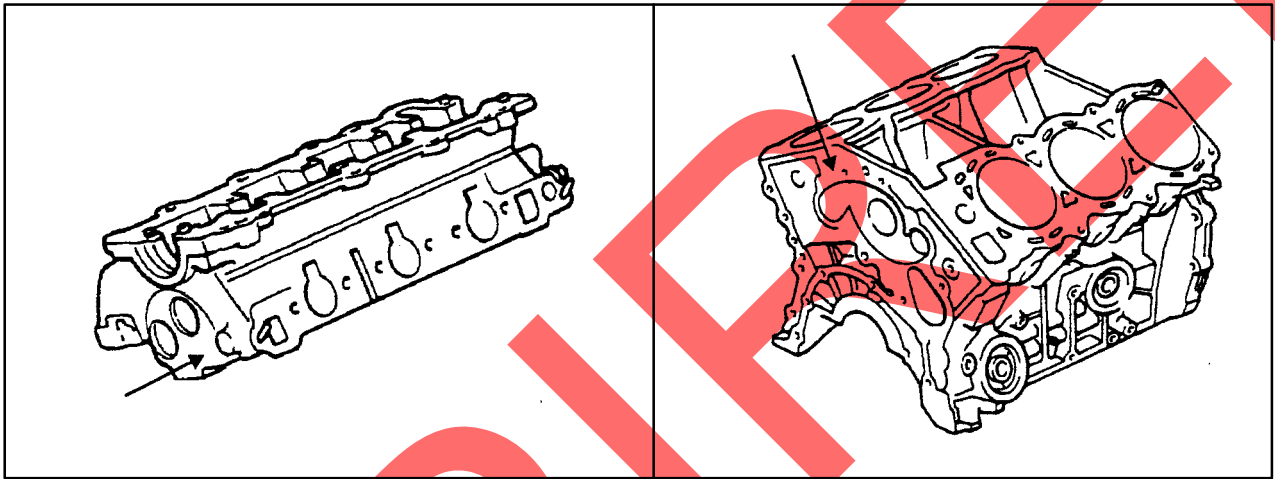
MACHINING INSTRUCTIONS

If the crankshaft connecting rods and pistons are serviceable and the cylinder block is not warped or eroded beyond specification, the block cylinder head surface may be machined.

In order to perform this machining operation correctly, equipment that will produce a smooth, flat, and scratch free surface must be utilized. In addition, this machine must be capable of accurately measuring the amount of material that is being removed. Following this machining operation the amount of material that has been removed must be indicated on the cylinder head and/or block by stamping the end surface as indicated.

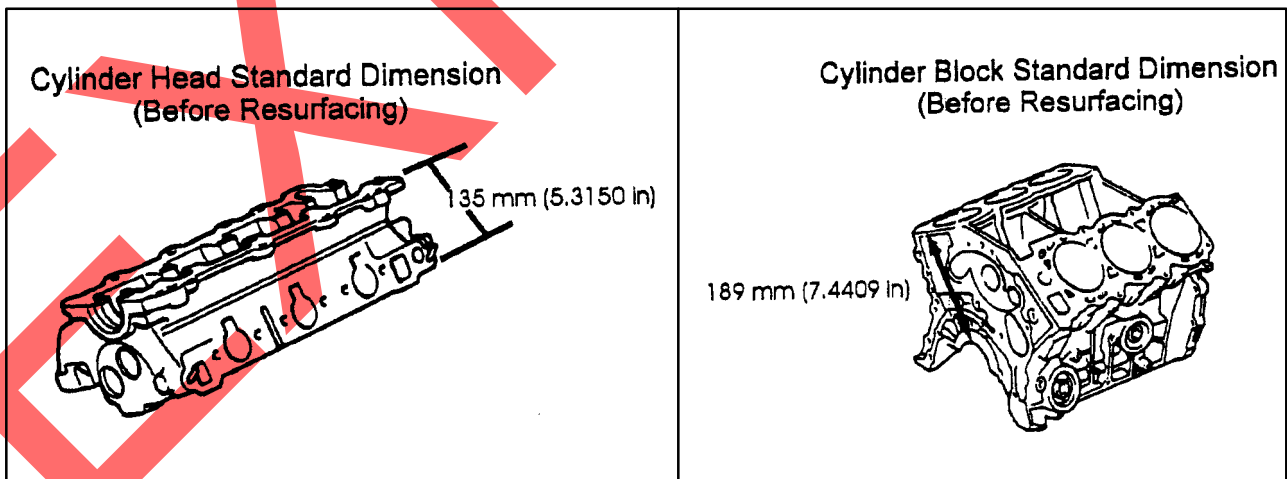
If you are uncertain as to whether or not a cylinder head or block has previously been machined, confirm the measurement of the head and/or block using the dimensions provided below.

Always thoroughly clean a head or block that has been machined to ensure that all residue from the machining operation is completely removed.
