# Abnormal Noise From Front Strut Mount

YEAR(S)	MODEL(S)	ADDITIONAL INFORMATION
2011 - 2017	CT200H

September 28, 2018 Rev1:

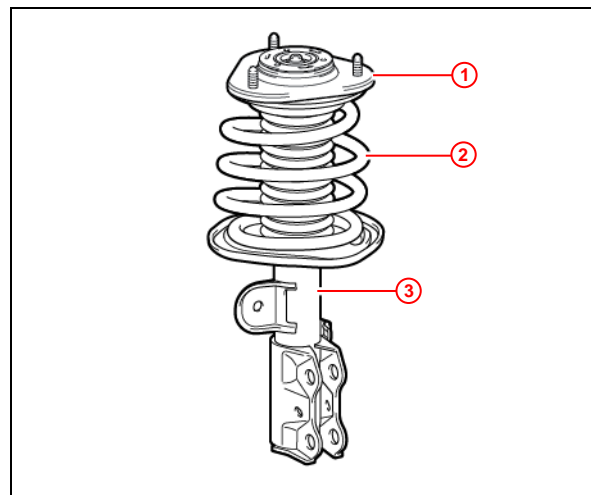
**Figure 1.**

Some 2011 – 2017 model year CT200h vehicles may exhibit a metallic clicking noise from the front of the vehicle when driving over a washboard-type road surface, or a creaking noise when turning left or right. A new Front Suspension Support Sub-assembly (front strut cap support) is now available to address this condition.

<b>1</b>	Front Suspension Support Sub-assembly
<b>2</b>	Coil Spring
<b>3</b>	Strut

4. Install the front strut assembly with the NEW front strut cap support.
