Technical product information

Topic	Engine oil in charge air coolers
Market area	Bentley: worldwide (2WBE),Hongkong-Macau (5HK)
Brand	Bentley
Transaction No.	2050222/4
Level	EH
Status	Approval
Release date

W12 TSI engine vehicles

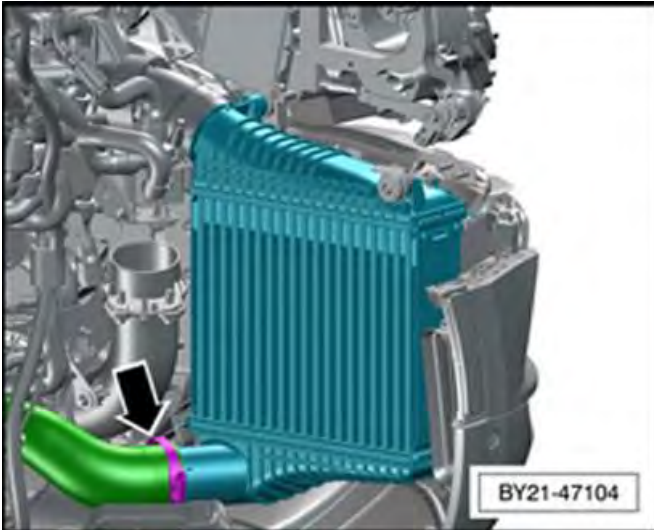
Liquid gugging noise evident from engine charge air intake system - Excessive oil discovered in charge air coolers. Low engine oil level may be displayed in the driver information panel

A specific level of oil residue is expected in a charge cooler. Currently the level of oil being seen in some Bentley charge air coolers is excessive. Investigations are taking place to identify the cause

Any oil found in the charge coolers should be drained off, any remaining oil residue should be cleaned from the charge coolers and hoses, the vehicle should then be returned to the customer.

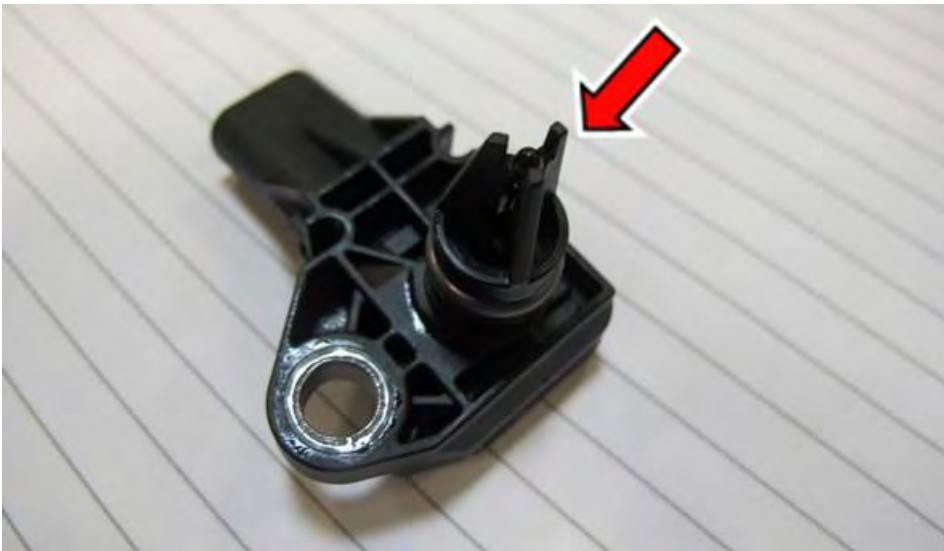
If after a road test of the vehicle the 'Engine management light' illuminates, check the fault memory of both engine control modules for either of the following DTC's;

"P2A0B00: Manifold Absolute Pressure Sensor "B" Circuit Range/Performance"

"P010600: Manifold Absolute Pressure or Bar. Pressure Sensor Circuit Range/Performance"

If either of the DTC's is stored, remove the relevant MAP sensor (G429 or G71) and check for oil contamination in the sensor. If found to be contaminated replace the affected MAP sensor.
