## Technical product information

<b>Topic</b>	'Instrument cluster: fault' on Drivers Instrument Panel . Fault code 'B200041-Control module faulty' stored
<b>Market area</b>	Bentley: worldwide (2WBE),Hongkong-Macau (5HK)
<b>Brand</b>	Bentley
<b>Transaction No.</b>	2051860/1
<b>Level</b>	EH
<b>Status</b>	Approval
<b>Release date</b>

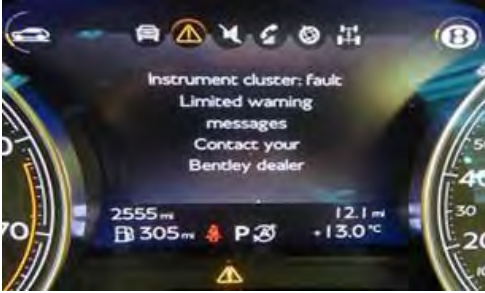
Message on Drivers Instrument Panel;

Instrument cluster: fault limited warning messages, contact your Bentley dealer.
