Fuel Cap "No Click" and/or "No Spring Return"

Service Category Engine/Hybrid System

Section Fuel System

YEAR(S)	MODEL(S)	ADDITIONAL INFORMATION
2017 - 2018	Tundra

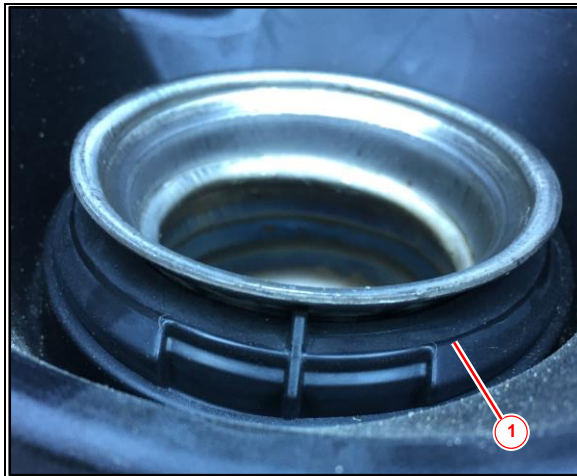
Figure 1. NG Condition

Some 2017 – 2018 model year Tundra vehicles may exhibit a “no click” or a “no spring return” condition from the fuel cap when fully seated and sealed. In some vehicles, the fuel cap may be contacting the fuel filler neck, leading to this condition. Follow the Repair Procedure in this bulletin to address this condition.

1 Contact With Fuel Filler Neck

2. Remove the fuel filler neck.
Refer to TIS, applicable model and model year Repair Manual:
 - 2016 – 2018 Tundra:
Engine/Hybrid System – Fuel System – “[1UR-FE](#) / [3UR-FBE](#) / [3UR-FE](#) Fuel: Fuel Tank: Removal”

3. Install the NEW fuel filler neck and fuel cap.

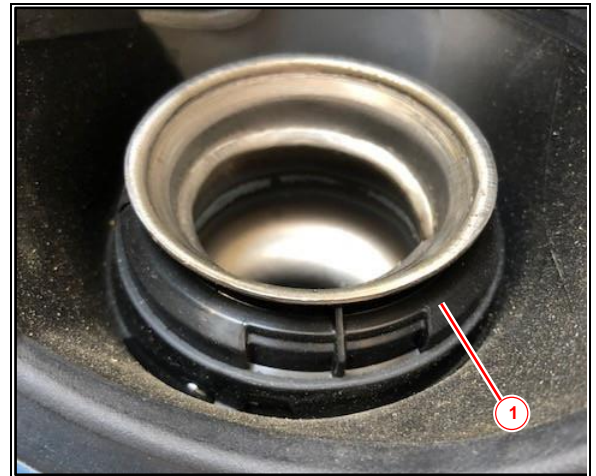
Figure 2. OK Condition

1 No Contact With Fuel Filler Neck
