JTBO0570NAS2

# TECHNICAL BULLETIN

Creak Noise From the Rear of the Vehicle When Accelerating, Braking, and/or Cornering

MODEL:	MODEL YEAR:	VIN:
F-PACE (X761)	2017	045591-081197

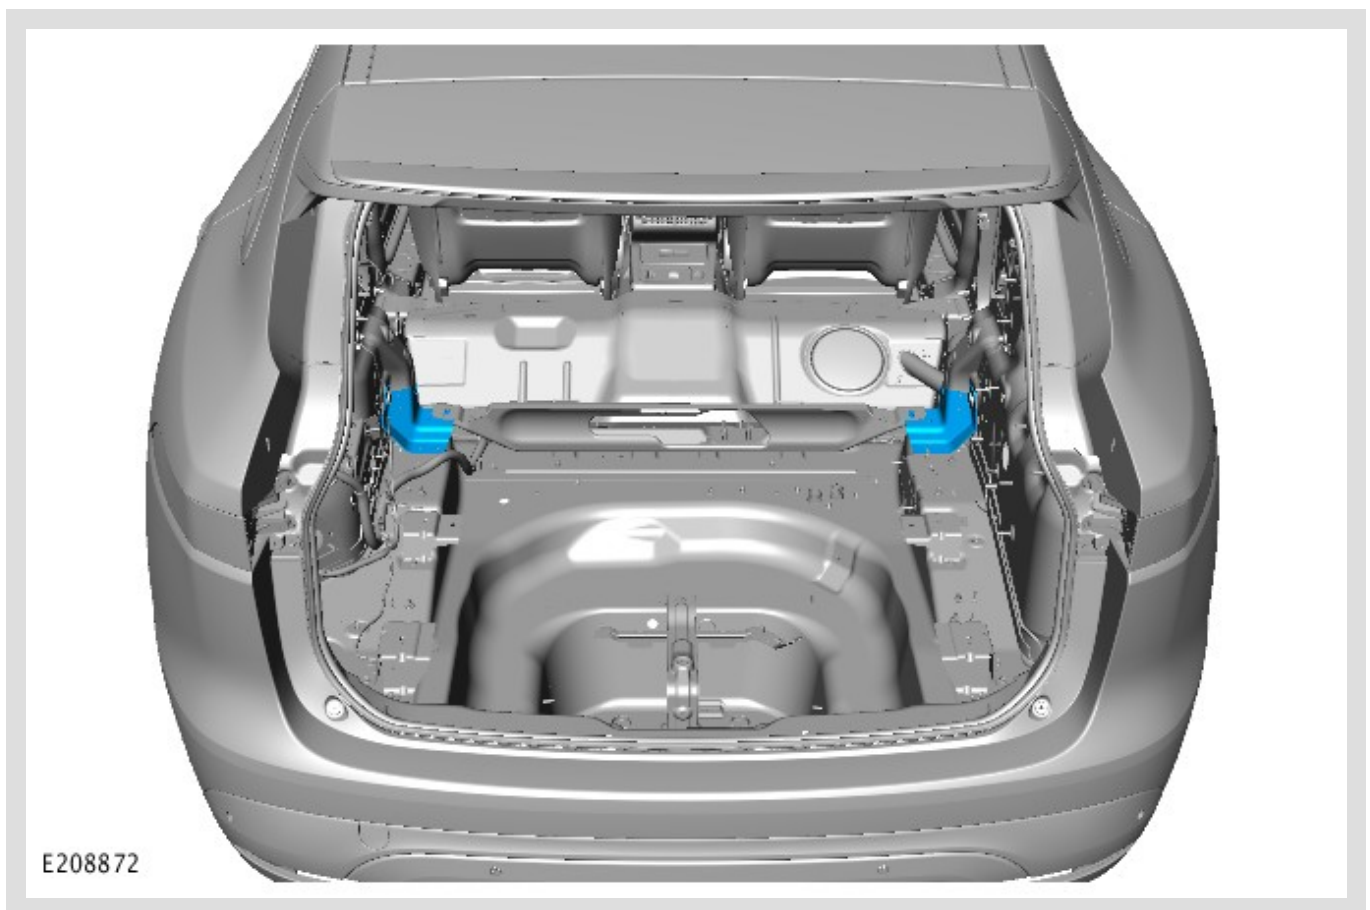
1

A creak noise may be evident from the rear of the vehicle when braking, accelerating, and/or cornering.

This may be caused by deformation of body panels.

Location of the repair.
