LTB01148NAS2

# TECHNICAL BULLETIN

204-02: Rear suspension

Knocking Noise From The Rear Of The Vehicle

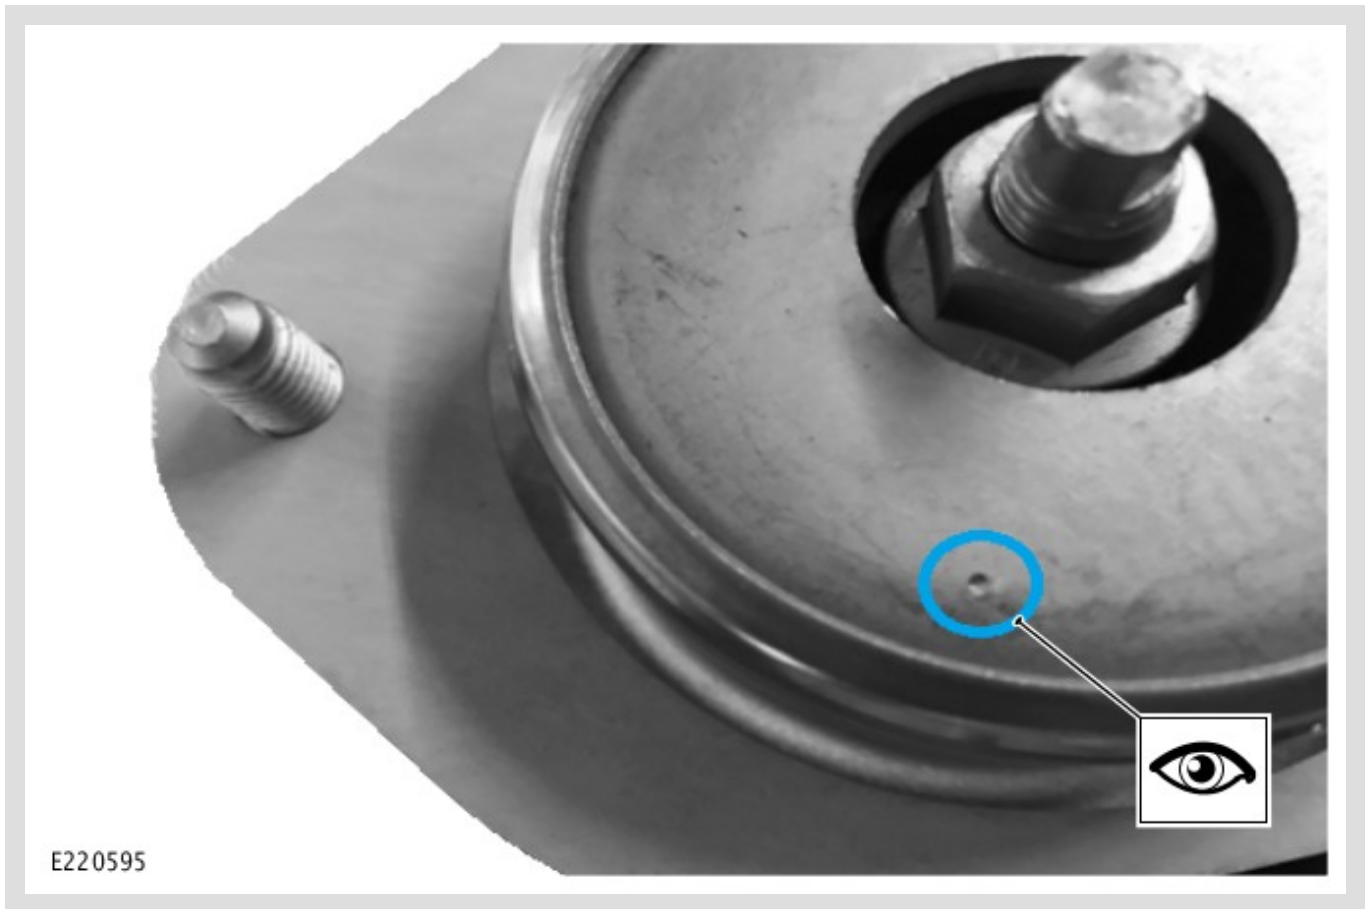
1

The new top mount should be identified with a 'dot' punch mark on the top plate.

Do not install a part that is not identified with a dot punch mark.
