LTB01060NAS2

TECHNICAL BULLETIN

501-11: Glass, Frames and Mechanisms

Power Windows Inoperative

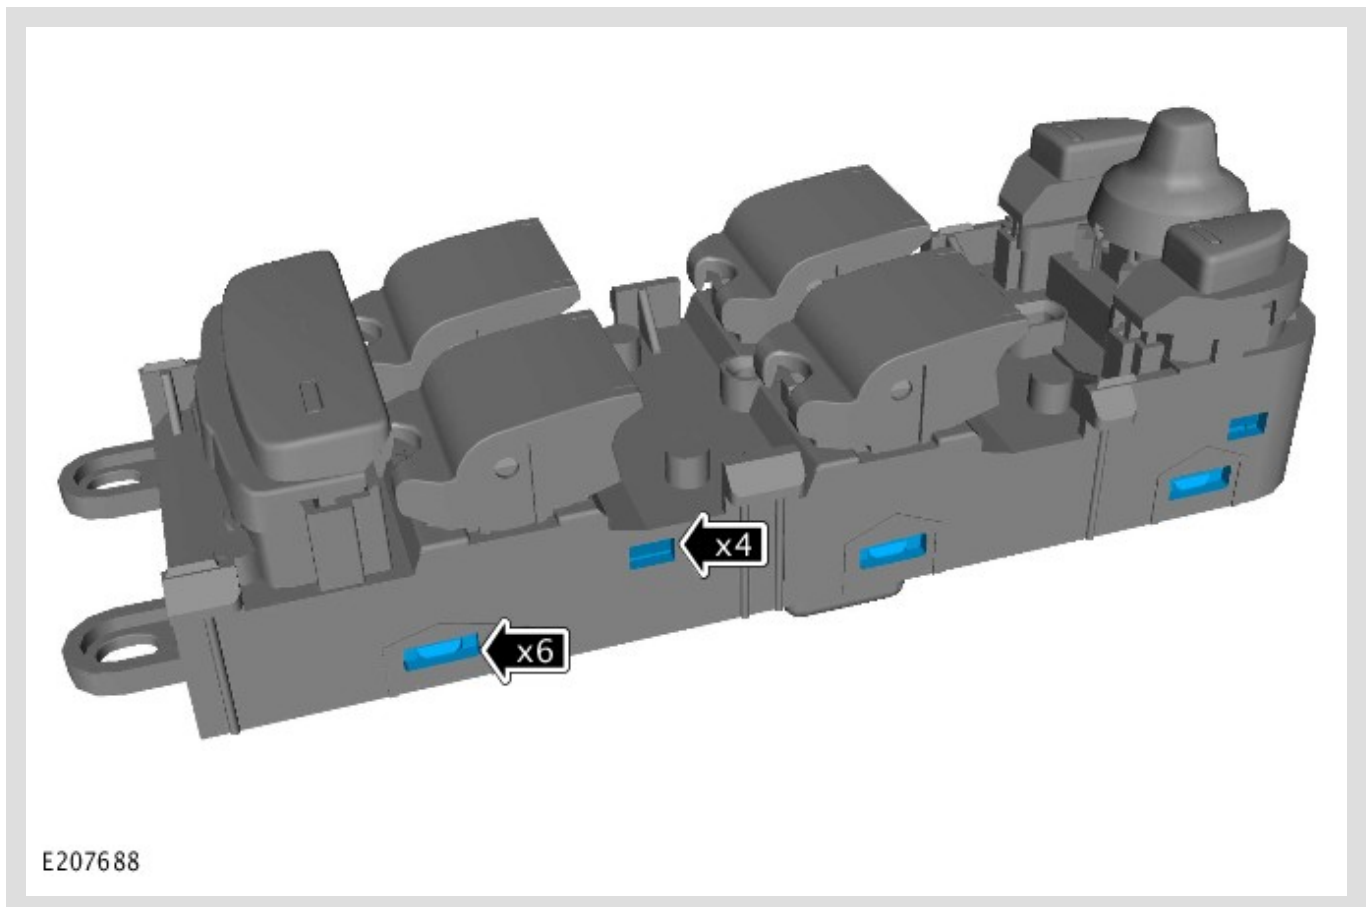
4

This may be caused by old stock driver door window switchpacks not having the required sealing tape installed, leading to water ingress.

Apply sealing tape to both sides of the **new** driver door (master) window switchpack, covering the side cavities on the driver door switchpack.
