JTB00646NAS1

TECHNICAL BULLETIN

501-25B: Body Repairs - Water Leaks

Water Ingress Into The Passenger And/Or Luggage Compartment

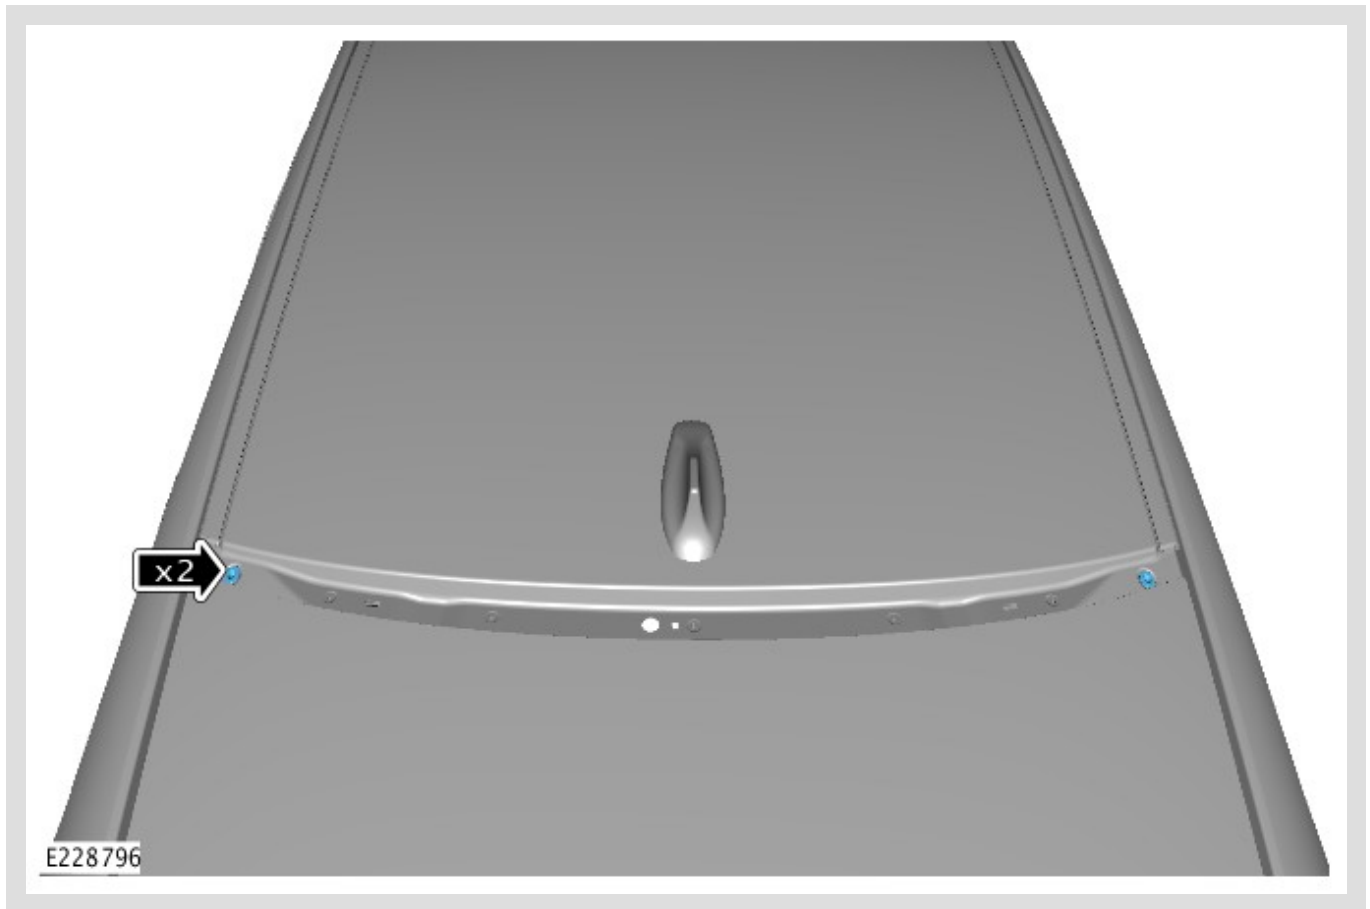
4

This may be caused by water ingress through the high mounted stop lamp location grommets.

Replace the 2 location grommets.
