Technical Journal

Vibrations due to wheel / tire

REF NO: TJ 32161.6.0	ISSUING DEPARTMENT: Technical Service	CAR MARKET: United States and Canada	
PARTNER: 3 US 7510 Volvo Car USA		ISSUE DATE: 2018-07-05	STATUS DATE: 2018-07-11
FUNC GROUP: 7726	FUNC DESC: Summer tire, separate	Page 1 of 5

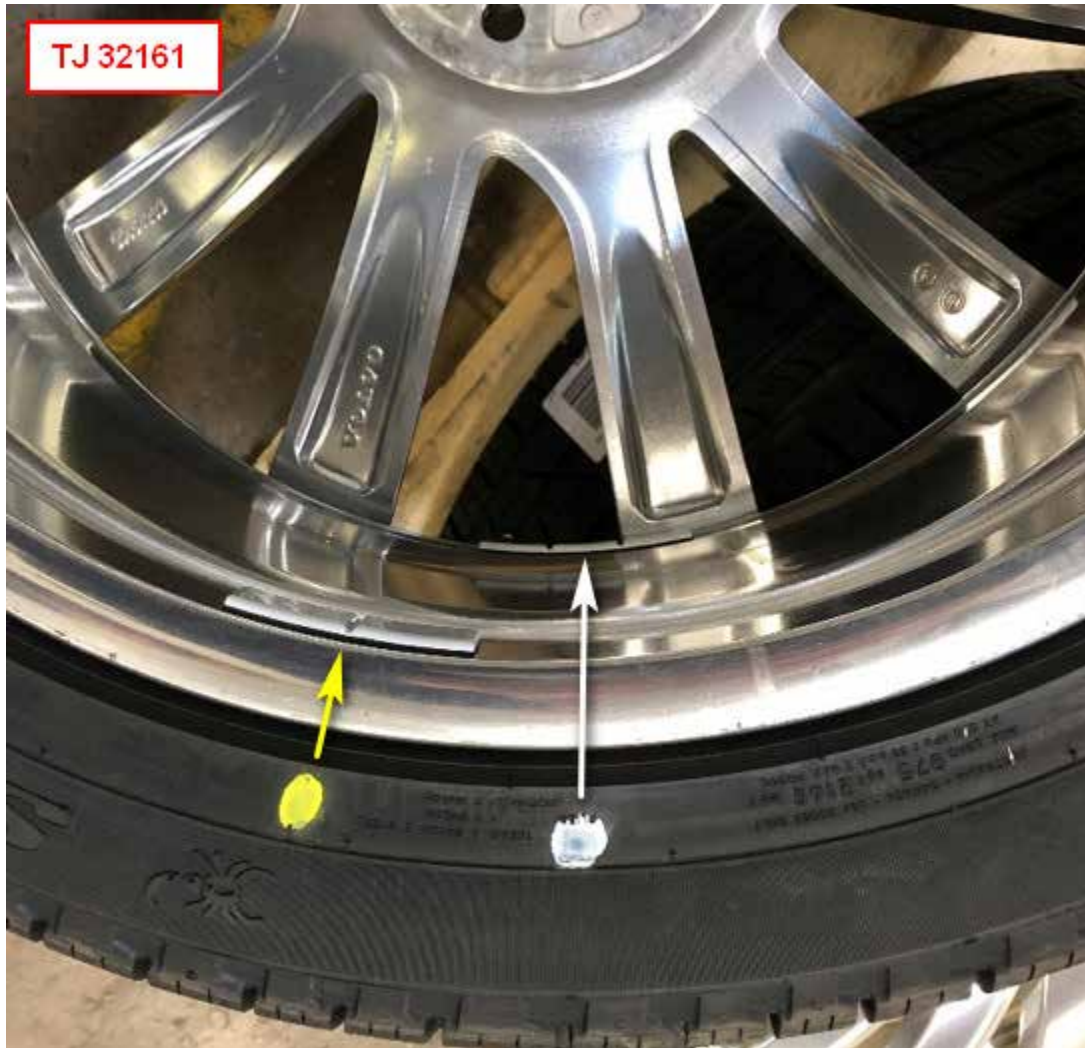
File Name	File Size
TJ 32161.jpg	0.0944 MB

Check that the rim is equipped with balancing weights. For newer wheels there should be visible white and a yellow dots printed on tire (inner side) indicating the location of the balancing weights, yellow for inner side, white for outer side (see photo). If balancing weights are missing but there are white and yellow dots on the tire, then it is likely that the weights has been lost and it is then needed to rebalance the tire.
