## SERVICE BULLETIN

**APPLICABILITY:** 2017-18MY Impreza  
 2018MY Crosstrek  
 2018MY Legacy and Outback  
 2018MY BRZ

**NUMBER:** 15-211-17R

**SUBJECT:** Reprogramming File Availability for Additional Optimization of Harman Gen 3 Audio and Navigation Head Units

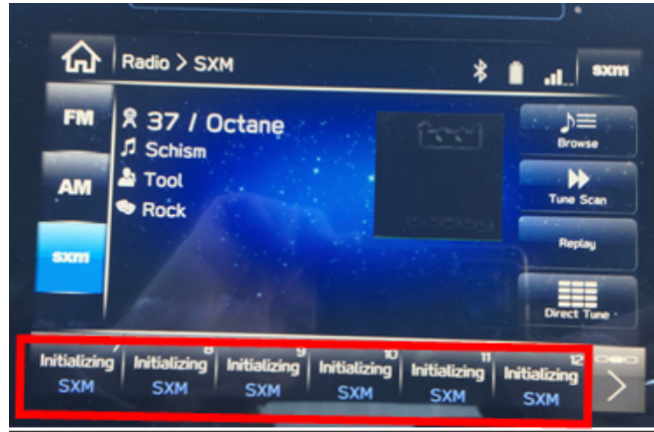
- On 2018MY Legacy / Outback models with Navigation (High) head units, the update corrects a condition where the head unit remains powered even after the ignition is OFF and the driver door is opened.
- Corrects for a condition where the SXM presets become lost and only “Initializing” appears as shown below.

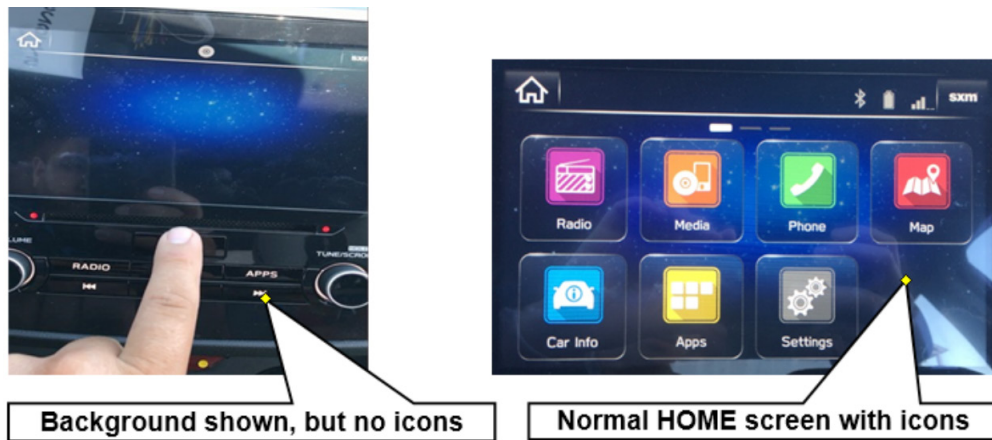
- Corrects for condition where only the star field background is displayed (without icons) after the HOME button is pressed.

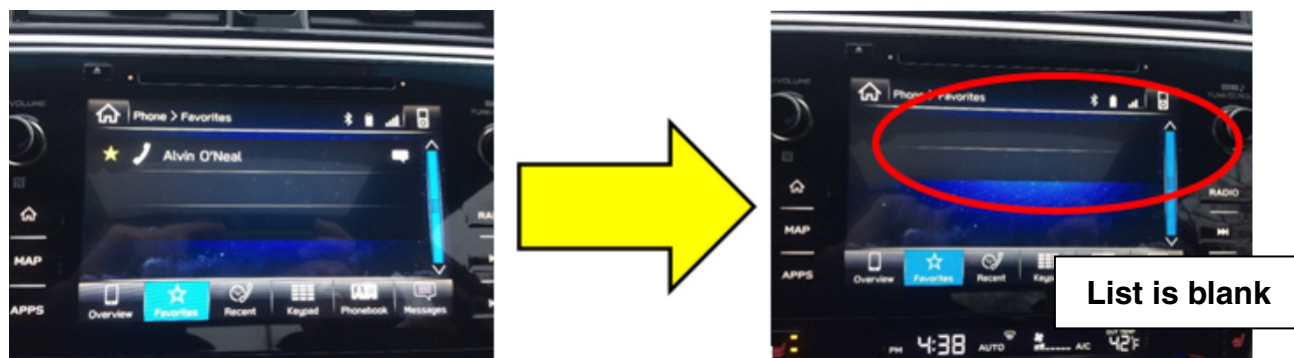
- Corrects for a “Pop” or “Crackling“ sound concern when listening to AM radio.
- Corrects for a concern of the head unit continually resetting itself.
- Corrects for a concern of after selecting a contact to be a “Favorite” and the “Favorite” list display is blank.

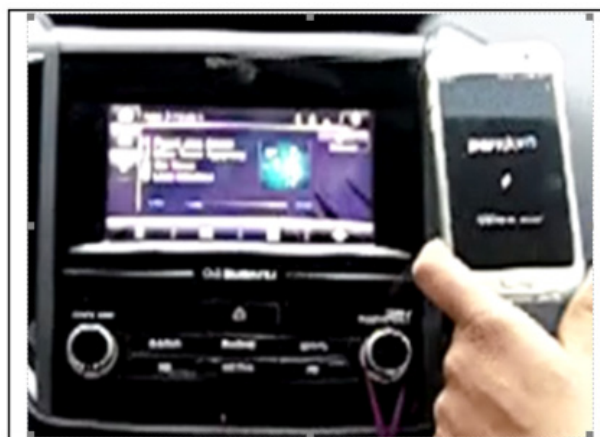
- 1- No streaming audio. When using the Pandora® app, there is no audio output.

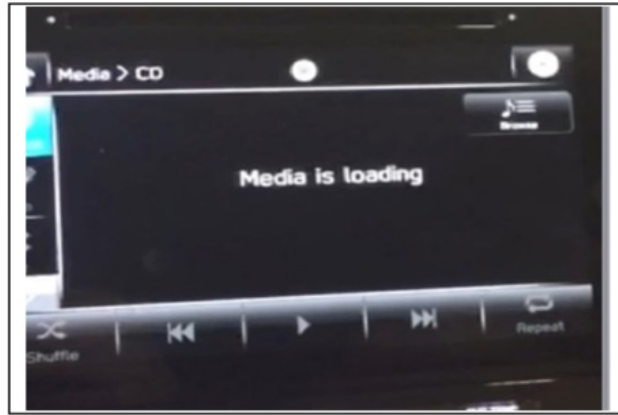
- 2- “Media is loading” is displayed on the screen but, the media never completes loading.

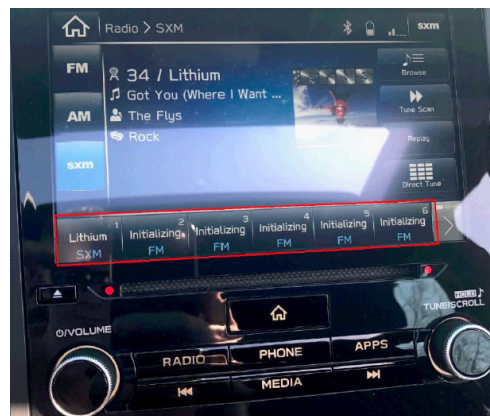
- 1- Radio station presets disappear (touch screen buttons return to “Initializing”).

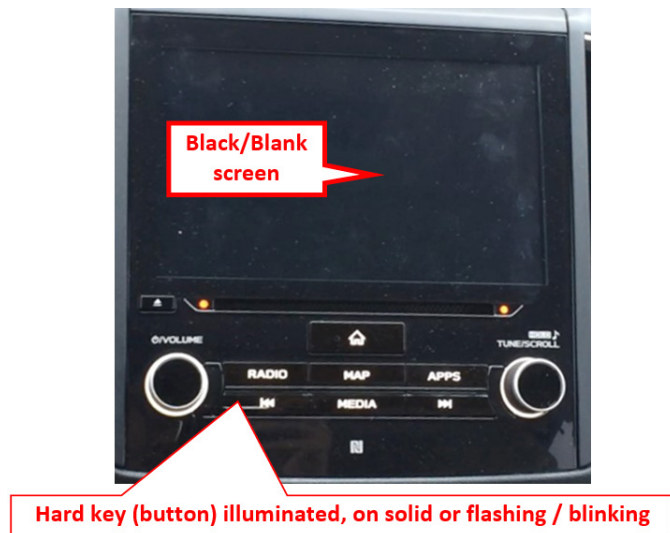
- 1) After switching the vehicle (ACC or IGN) on, the display screen goes black with no audio output and the hard key buttons are illuminated (on solid, or flashing / blinking).

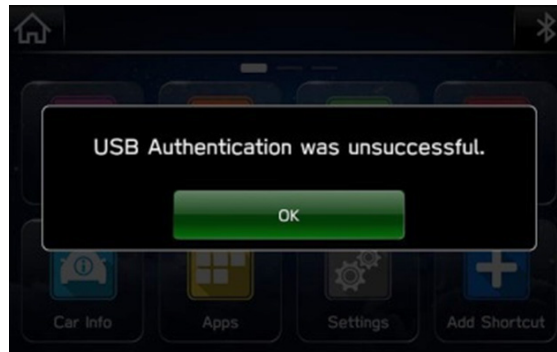
**NOTE:** If an attempt is made to install the wrong “grade” file into the wrong grade head unit (EXAMPLE: “Base” update file into a “Mid” or “High” head unit), the USB Authentication error screen below will be displayed:
