## CROSS TRAFFIC WARNING MISSING FROM INTEGRATED OWNERS MANUAL

G30 (5 Series Sedan)

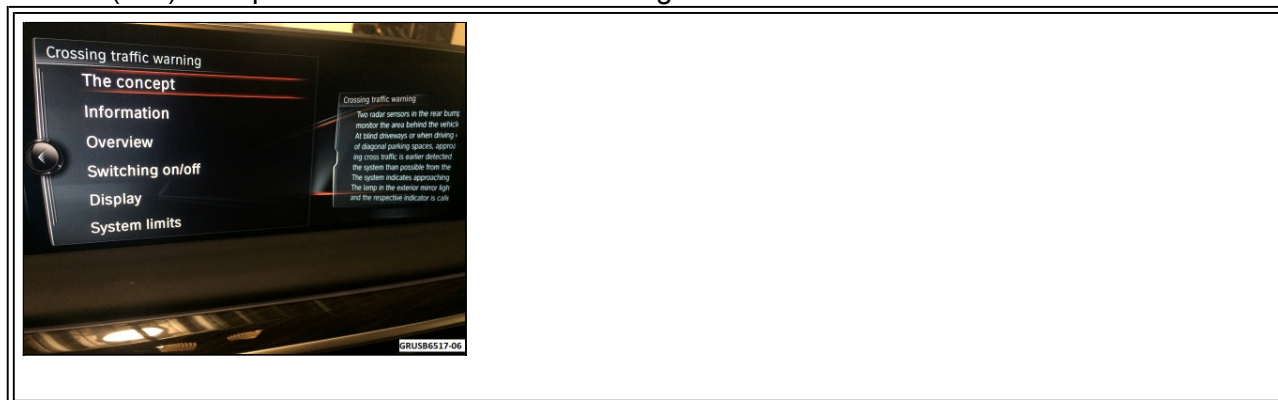
The crossing traffic warning (right of way warning) section is missing from the integral owner's manual (IBA). The picture below shows the missing text.

Software error in the Head unit IBA file

Reprogram and encode the vehicle with ISTA/P 3.62 or ISTA 4.06.01
