WRONG OUTSIDE TEMPERATURE DISPLAY

G12 (M760Li_xDrive)

Produced to June 01, 2017

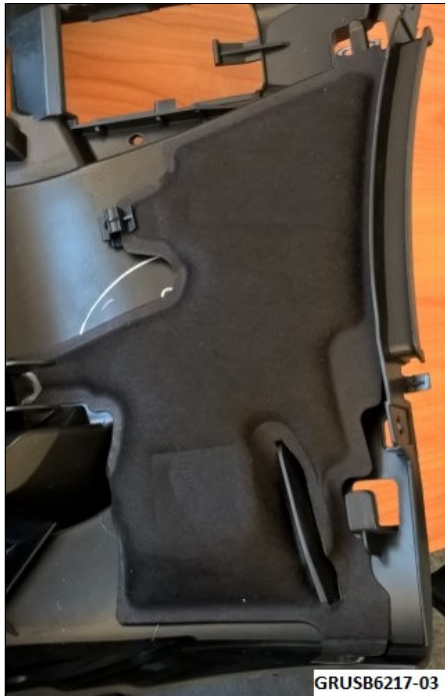
During stop and go or slow driving, with the engine at operating temperature, the ambient outside temperature display deviates in the instrument cluster by up to +10 degrees from the real ambient temperature.

Location of ambient temperature sensor. Temperature readings are influenced by:

- External engine oil cooler.
- Ambient temperature of operating engine compartment.

Install thermal protection insulating mat for the outside temperature sensor. This mat is installed behind the front bumper cover on the passenger side of the vehicle.

2. Follow REP 51 11 157 to access right side of front bumper cover.
3. Install the thermal protection mat for the outside temperature sensor. (See Step 16 of the REP for details on installation location).
