SI B51 27 17  
Body Equipment

## REAR WINDOW ROLLER SUNBLIND DOES NOT DEPLOY

G12 (7 Series)			
----------------	--	--	--

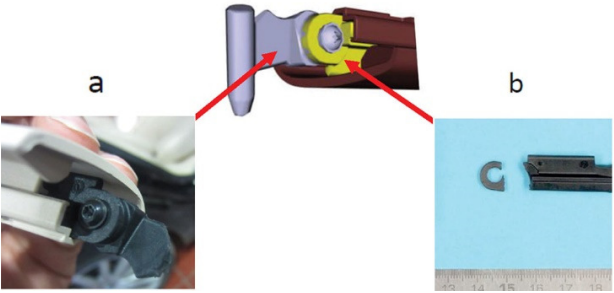
<ol style="list-style-type: none"> <li>1. Examine affected attachment point of roller sunblind to determine the correction needed.  <b>Is the broken component the one that slides in the guide rail (a) or is it the part directly attached to the roller trim (b)?</b>  <b>(a) is broken-</b> replace roller sunblind according to <b>REP 51 46 013</b> "Remove/replace/install roller sunblind".  <b>(b) is broken-</b> go to next step.</li> </ol>
