Grating or Scraping Noise When Turning Steering Wheel

This Service Information bulletin replaces SI B61 19 15 dated **September 2015**

F25 (X3)	F15 (X5)	F16 (X6)	I01 (i3)
I12 (i8)	Produced from June 30, 2013

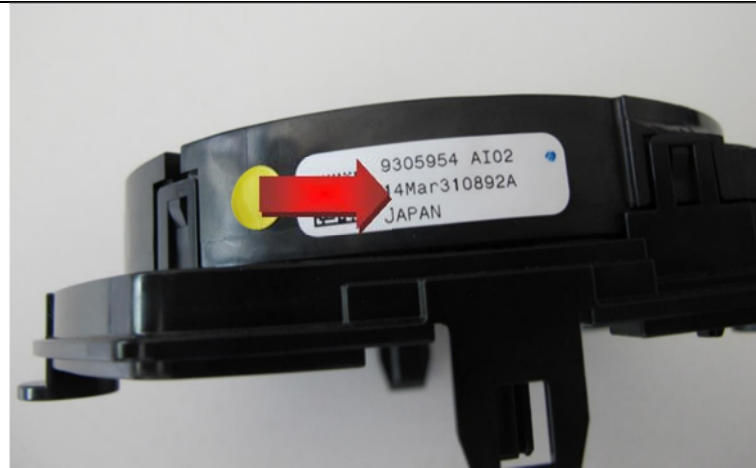
If there is a buzzing noise coming from the steering column, proceed as follows.

Check the label on the coil spring cassette as shown in the picture.

If the revision index is not "AI03" or the production date is earlier than "14May01", replace the coil spring cassette.

In the example in the picture, the label shows a revision index of "AI02" and a production date of "14Mar31" and must be replaced.

Always inspect the label on the new part to ensure it is the updated part.

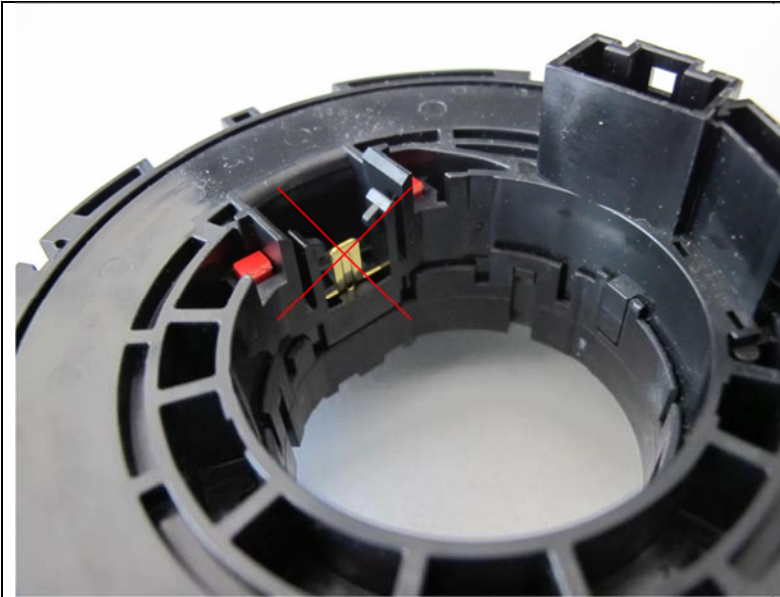
Check the coil spring cassette for a metal tab as shown. If the coil spring cassette has a tab, replace it.

The updated coil spring cassette is identified by inspecting the label on the coil spring cassette. It should indicate a revision index higher than "A102" and a production date after "14Jan20".

If the coil spring cassette does not have a metal tab continue to the next step.

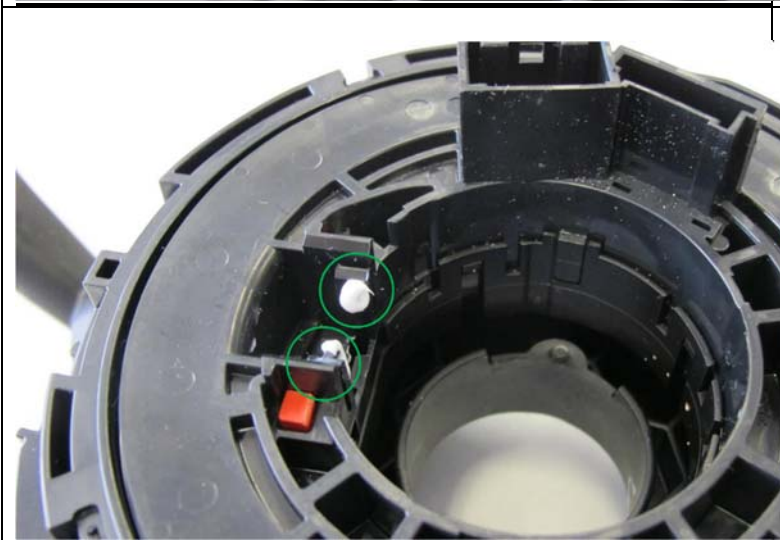
Check the highlighted tabs for grease as shown.

UPDATE! If no grease is present, use 83 23 9 407 810 and put a touch of grease on the highlighted spots. Do not use any other grease or the plastic will be damaged.

Reassemble the SZL and steering wheel and retest for noises.
