SI B33 04 16
Rear Axle

September 2016
Technical Service

SERVICE ACTION: REPLACE REAR-AXLE DIFFERENTIAL

This Service Information bulletin supersedes SI 33 04 16 dated August 2016

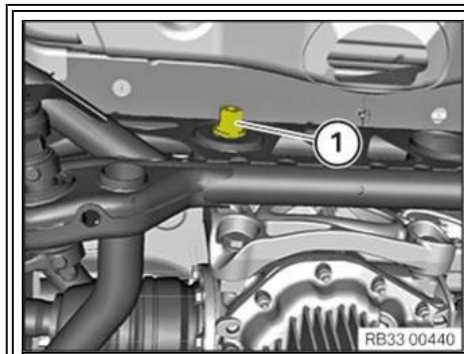
During the repair, when releasing rear differential Hexagonal collar bolt M14x1.5x125 (PN 33 17 7 852 488), make sure that the bolt's hex head does not show any marks indicating previous removal. In case bolt M14x1.5x125 (1) has been removed (torque released) previously, it needs to be replaced together with 4 sub-frame Torx screws M12x60 (PN 33 30 2 284 642).

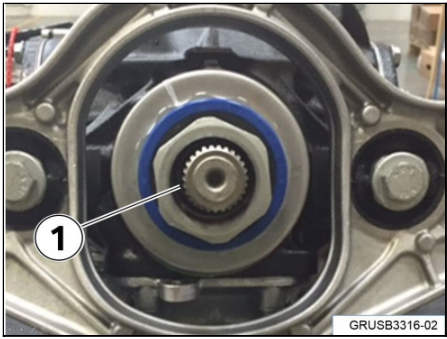
F8x produced from 06/29/2016

<p>Identifying the 8 090 473 differential: Check the number of splines on the old/new differential. The correct differential has 27 splines (1)</p>
---	--
