## EXTERIOR MIRRORS GO TO RANDOM POSITION

F48 (X1)
----------

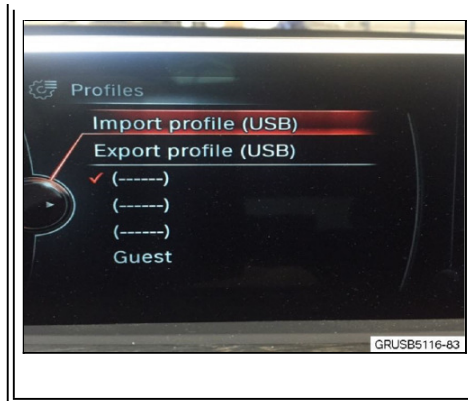
In response to conditions similar to:

4. Verify that the customer's preferred seat/mirror settings are applied to the correct profile position.  
**Note:** If possible, set all three profile settings to the same customer preferences.
