## RATTLE/BUZZ IN SUNSHADE

F48 (X1) produced to May 31, 2016

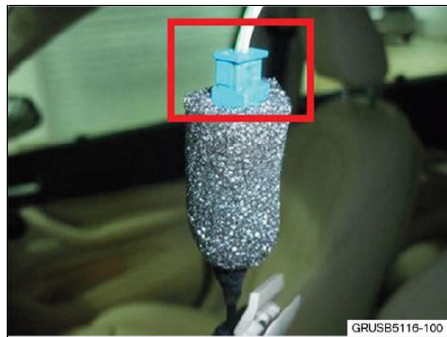
There is a rattle or buzz originating from the vicinity sunshade/ hands-free microphone, usually while driving on a rough surface.

Uncovered microphone plug vibrates against components behind headliner.

Cover microphone plug with tape or foam
