This Service Information bulletin and attachment supersedes SI B11 08 15 **dated June 2015**.

**N63 Engine: Valve Seal Replacement**

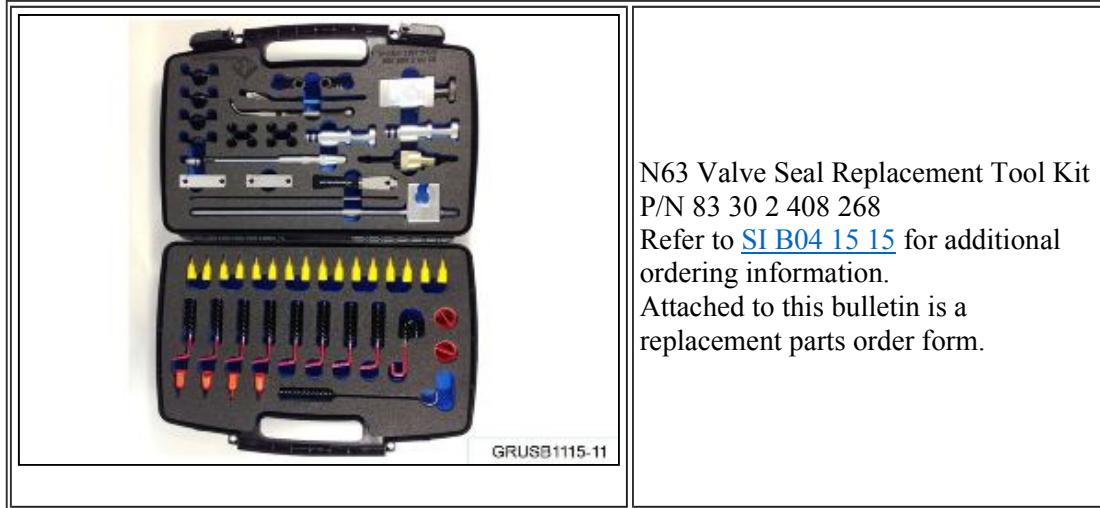
If one of these conditions is verified, replace the intake and exhaust valve stem seals using special tool P/N 83 30 2 408 268.
