<b>Technical Service Bulletin:</b> TSB150153	<b>Released Date:</b> 16-Oct-2018
<b>Fault Code 3314, 3317, 3319, 3146 or 4518 Caused by Aftertreatment Exhaust Gas Temperature Sensor Malfunction</b>

## Fault Code 3314, 3317, 3319, 3146 or 4518 Caused by Aftertreatment Exhaust Gas Temperature Sensor Malfunction

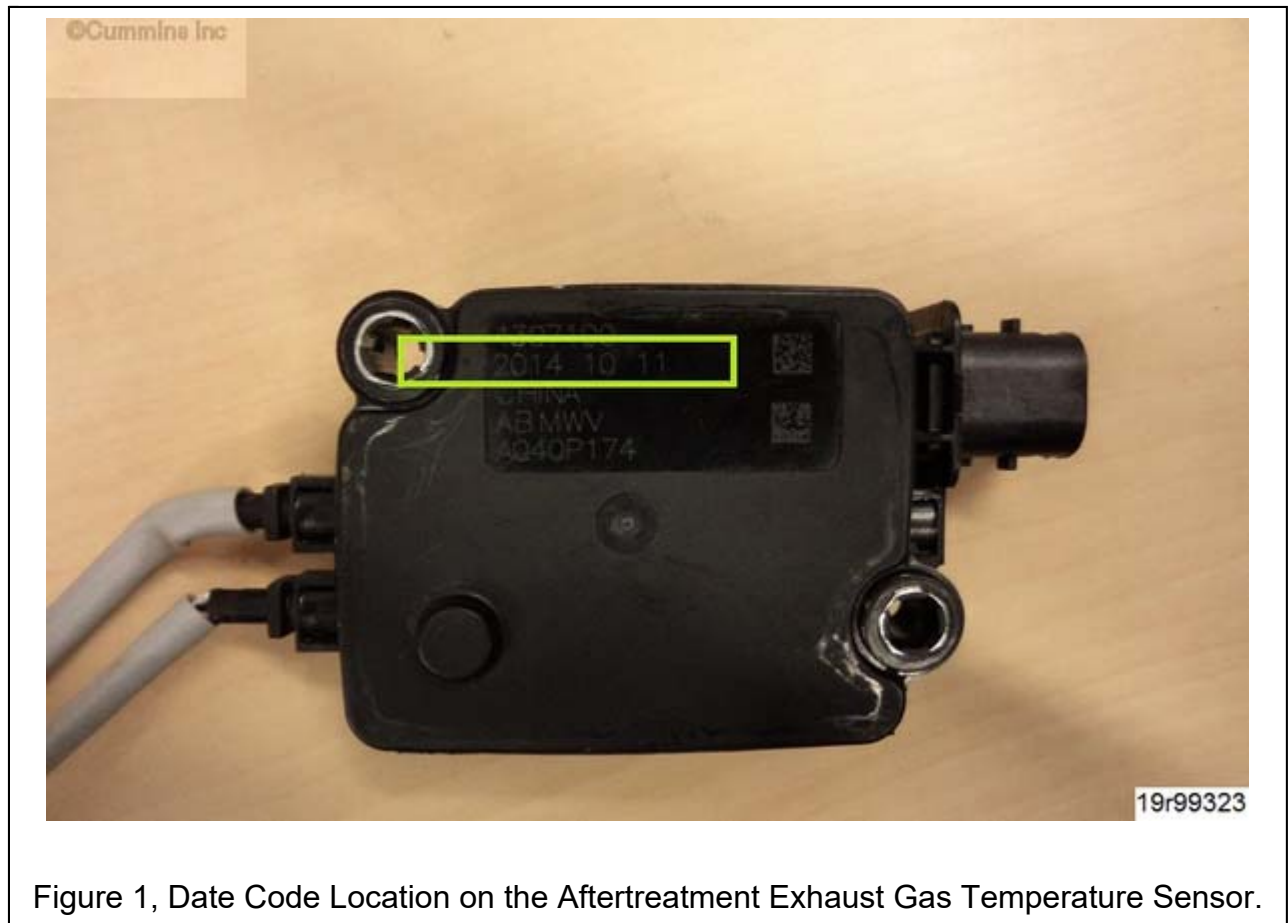
<b>Table 1, Aftertreatment Exhaust Gas Temperature Sensor Inspection Criteria</b>			
<b>Part Description</b>	<b>Date Code On Sensor Body<sup>1</sup></b>	<b>Markings<sup>2</sup></b>	<b>Action</b>
Aftertreatment Exhaust Gas Temperature Sensor	20150730 and before	No marking	Do <b>not</b> use
	20150730 and before	White half circle and a pink line on the hexagon nut	OK for use
	20150514 and before	Two white lines on side of housing	OK for use
	20150730 and before	White half circle on the hexagon nut	OK for use
	20150730 and before	White half circle with pink dot on the hexagon nut	OK for use
	20150730 and before	White dots on sensor body	OK for use
	20150731 and after	No marking or two parallel white bars on the hexagon nut	OK for use
<sup>1</sup> See Figure 1 Below. <sup>2</sup> See Figure 2 and Figure 3 Below.

If the aftertreatment SCR exhaust gas temperature sensor or the aftertreatment DPF exhaust gas temperature sensor requires replacement, the new aftertreatment exhaust gas temperature sensor **must** be inspected prior to installation. See Table 1 below.
