Volvo Model VNL

Title Volvo Chassis - Fender Panel Crack Repair - **Model Year 2018 And Newer**

Cause The purpose of this document is to outline the process to repair cracks in Volvo SMC fender panels for hoods on model year 2018 and newer VNL models.

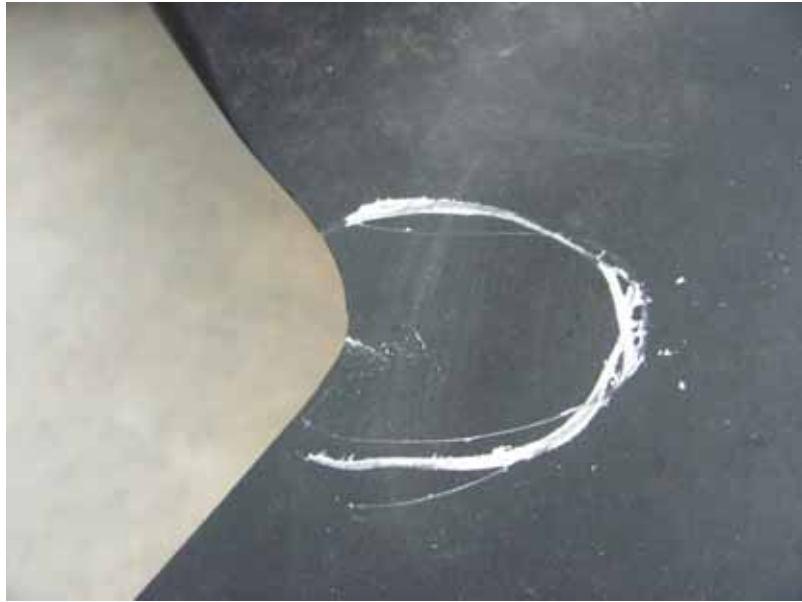
1. Mark all areas to be repaired.
