## Brake Disc and Brake Pad Service and Reference Information

This Service Information bulletin supersedes SI 34 06 13 **dated March 2015**.

Determining when to service brake components

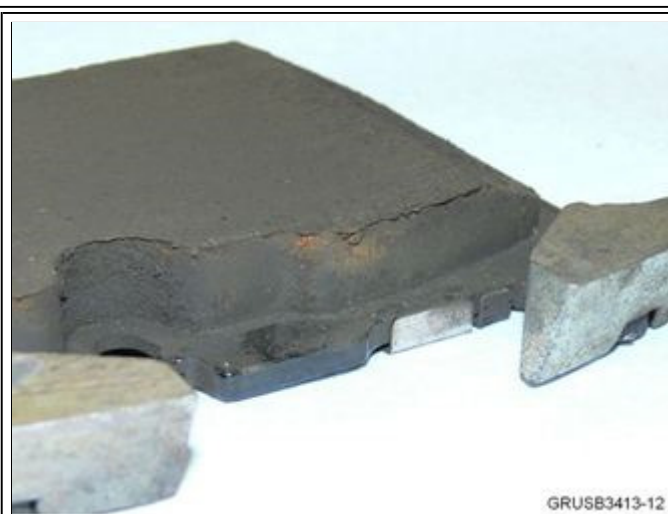
#### 1. Brake Noise

Most brake squeal noise is produced by vibration of the brake components. This vibration/oscillation will build up a resonance which is heard as a brake squeal.

The type and occurrence of this noise varies, based on driving profile, environmental conditions and build up of debris on brake components.

Submit a PuMA Info Only case when servicing the vehicle for a customer complaint of brake noise.

Include in the case:

- Identifying the correct axle
- Photos of the pads, discs and calipers
- Sound recording/video of noise occurring

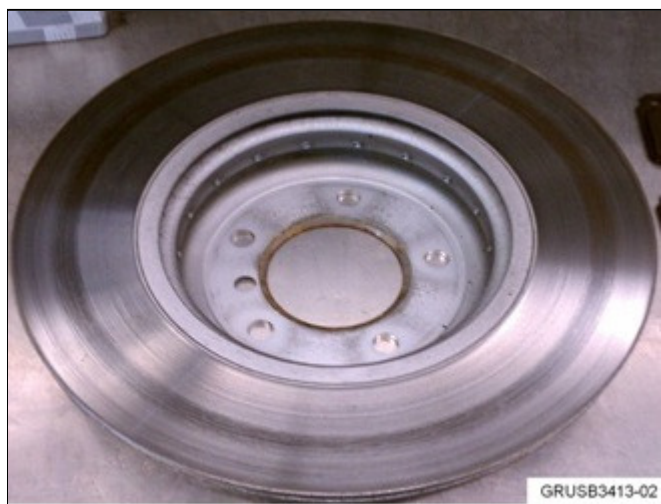
## 2. NAO-specific color transfer since 2009 introduction

Non-asbestos Organic (NAO) brake pad material, by design, reduces brake dust and may generate a visible dark transfer layer between pads and discs. This behavior is specific to the state-of-the-art technology found in NAO pad material. The pad compound incorporates nonferrous metal, which can affect the appearance of the brake discs. Color transfer on friction surfaces: With heavy or extreme braking, color transfer to the disc from the pads is intensified and may generate dark spots or circular traces. Normal braking will gradually reduce the discoloration. This will not affect braking performance. No repair attempt is needed.

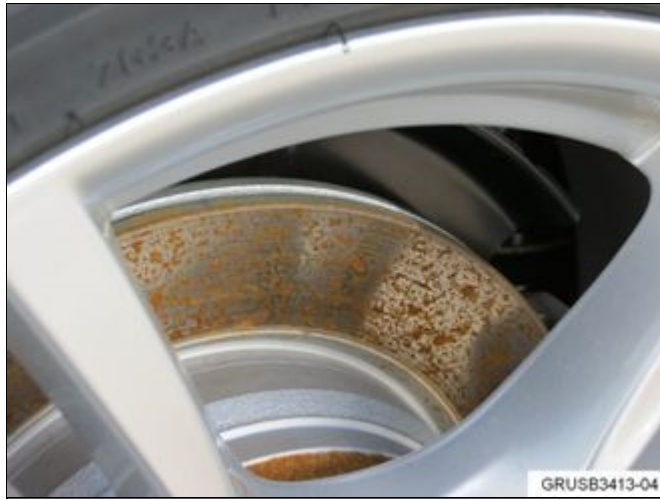
## 3. Light rust on friction surfaces

Brake disc friction surfaces are exposed metal. When not in use and exposed to environmental elements (moisture, salt, dirt), surface rust can

form. During initial braking, this will self-clean and an audible groan and/or noise is temporarily heard until the disc surface is cleaned. This will not affect braking performance. No repair attempt is needed.

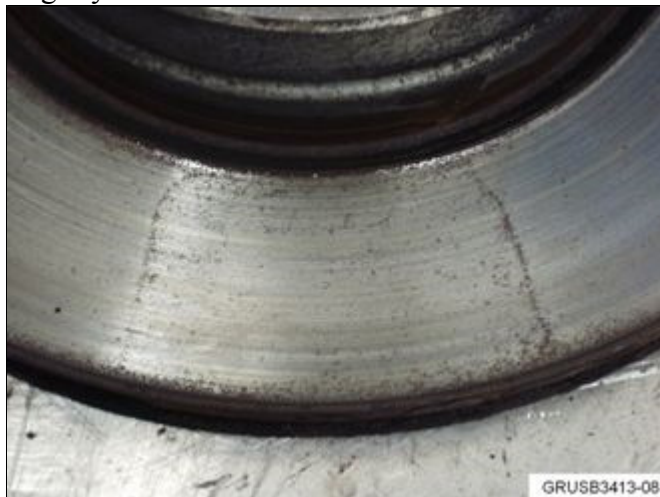
Slightly stained

Slight traces of corrosion on the brake disc friction ring (remains of stained spots): this is the normal condition of a vehicle that is stationary and has not been in use. This corrosion varies with ambient elements. The appearance will not affect braking performance and will diminish with everyday use. No repair attempt is needed.

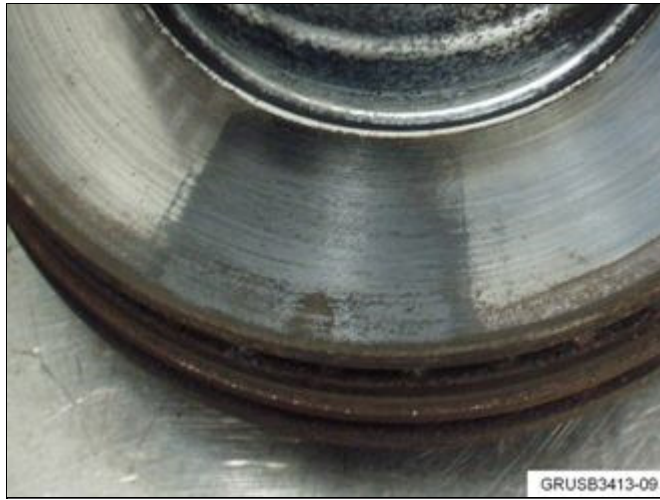
Significantly stained

Significant signs of corrosion on the friction ring: this is the normal condition of a vehicle that is stationary and has not been in use. This corrosion varies with ambient elements. The appearance will not affect braking performance and will diminish with everyday use. No repair attempt is needed.

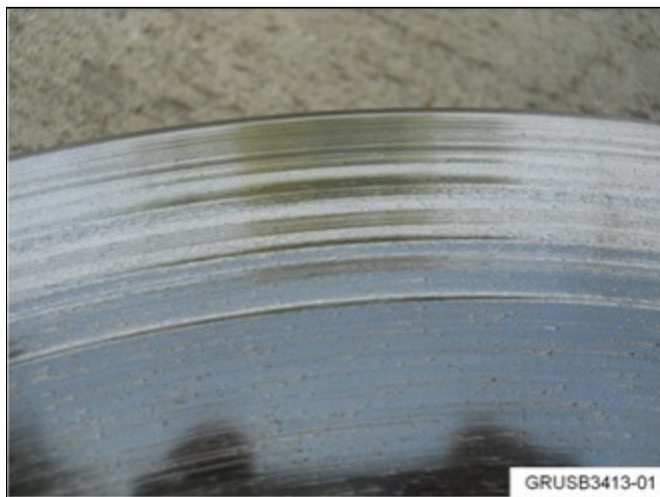
## 5. Grooves

Grooves are formed when debris is trapped between the pad and the disc. Debris entry is inherent in the disc brake cooling design. Current wheel styling exposes more of the brake components.

Grooves in the brake discs can be seen through these wheel openings and are purely visual; this in no way affects braking performance. No repair attempt is needed.

However, the groove depth must be evaluated to determine if replacement is necessary. If the groove's or grooves' depth goes beyond the minimum thickness, disc replacement is necessary.

- Always refer to the Repair Manual for model-specific information.
- Always replace discs in pairs (per axle).

- Install new brake pads when replacing discs.

Attach a hang tag to the inside rearview mirror after completion of repair work.

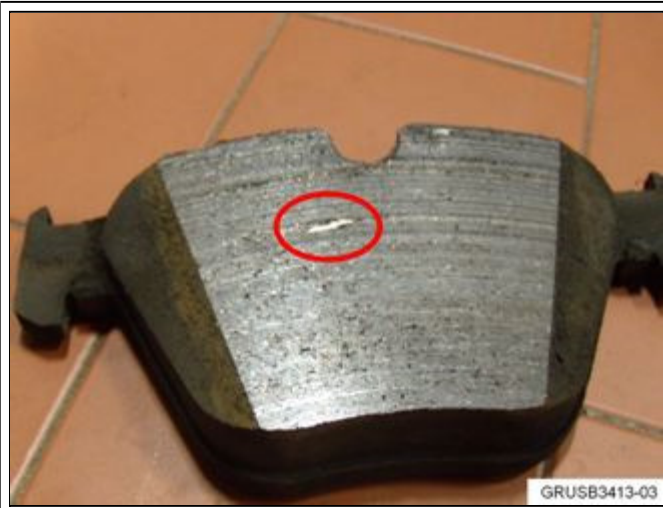
## 6. Embedded Material in Brake pad

Improper “bedding in” of the new brake pads and discs can cause the rotor material to flake off. This debris can become lodged in the pads and cause this appearance. This appearance will not affect braking performance. No repair attempt is needed.

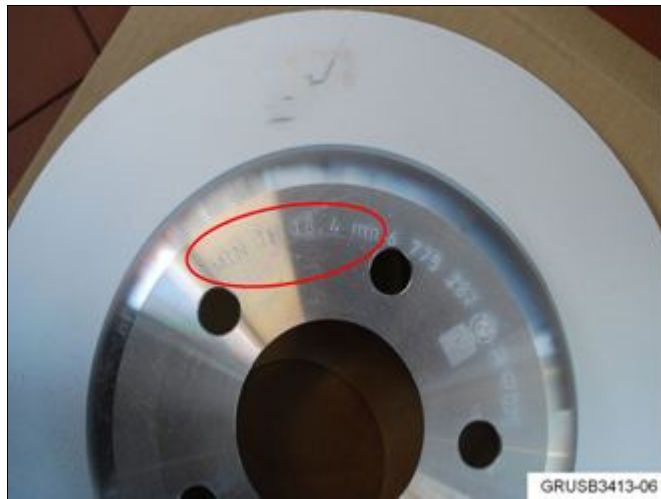
## 8. Minimum Thickness

BMW brake discs are stamped with a minimum thickness value. The stamped minimum thickness is used to determine if the brake discs require replacement during a brake service. Some motor vehicle inspection procedures (state-dependent) require the measurement of brake discs for safety consideration. A separate minimum thickness specification is provided in the Repair Manual. An example of the specifications is described below.

The Minimum Thickness for general inspection (Motor Vehicle Inspection) is defined as follows:

- New disc thickness minus 2.4 mm (not applicable to perforated brake discs and M vehicles)

- Always refer to the Repair Manual for model-specific information.
- Always replace discs in pairs (per axle).

- Install new brake pads when replacing discs.

Attach the hang tag to the inside rearview mirror after completion of repair work.

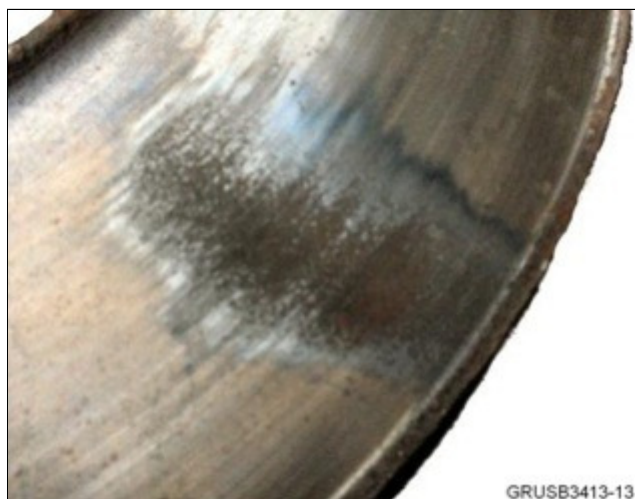
## 10. Brake Overheating

Discoloration and/or visible hard spots indicate brakes that have overheated. Inspect the brake components for error-free operation (calipers binding, hydraulic restrictions, etc.). If no mechanical/hydraulic defects are found, this can be attributed to improper brake usage. In this case, the discs have to be replaced (not under warranty).

- Always refer to the Repair Manual for model-specific information.
- Always replace discs in pairs (per axle).
- Install new brake pads when replacing discs.
- Attach the hang tag to the inside rearview mirror after completion of repair work.
