NEW N47T: Diesel Particulate Matter Sensor Faults Stored in DDE

F25 (X3 xDrive 28d)

F30 (3 Series Sedan)

F31 (3 Series Sport Wagon)

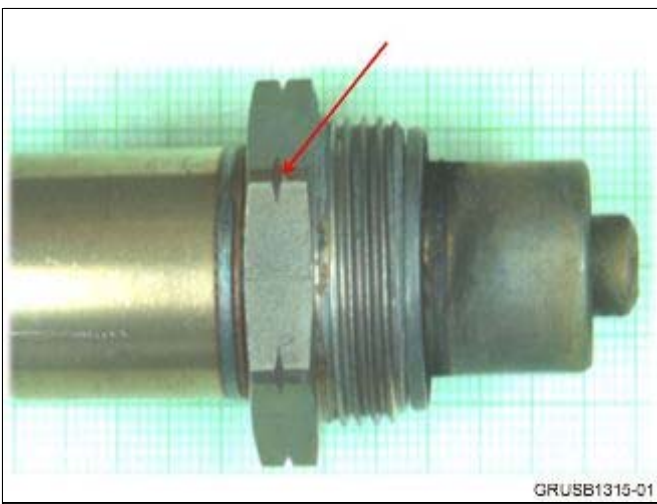
The PM sensor has been redesigned and was phased into production beginning 7/2014.

NEW The redesigned particulate matter sensor can be identified by the presence of notches in the union nut.

NEW Replace the PM sensor and program the vehicle using the latest version of ISTA/P.
