Water Ingress into the Luggage Compartment after opening the Tailgate

F34 (3 Series Gran Turismo)

Produced from February 28, 2013 to August 27, 2015

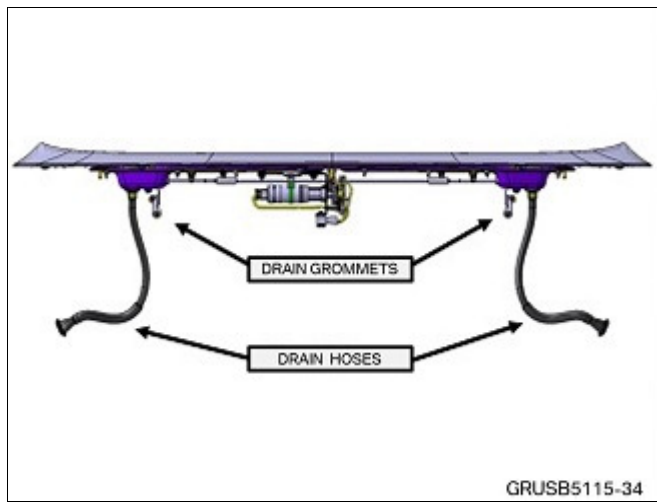
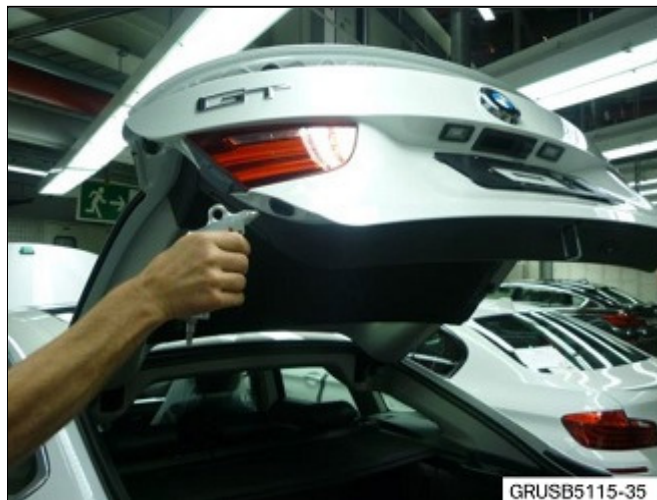
The water drain hose(s) on the rear spoiler is blocked.

<p>Use Repair Instructions 51 49 000 and remove the rear trim panels.</p>
--	---

- Check both water drain hoses for obstructions and clean with compressed air if needed.
- If the drain hose cannot be cleared, then replace as needed.

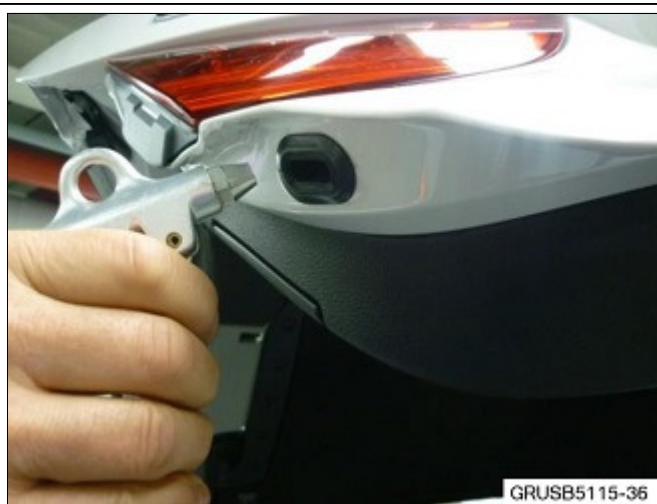
The close up shows the drain area of the driver's side.
