Service Action: Emergency Call Button - Backlighting Is Not Working

F34 (3 Series Gran Turismo)

F36 (4 Series Gran Coupe)

Produced from July 27, 2015 to July 30, 2015

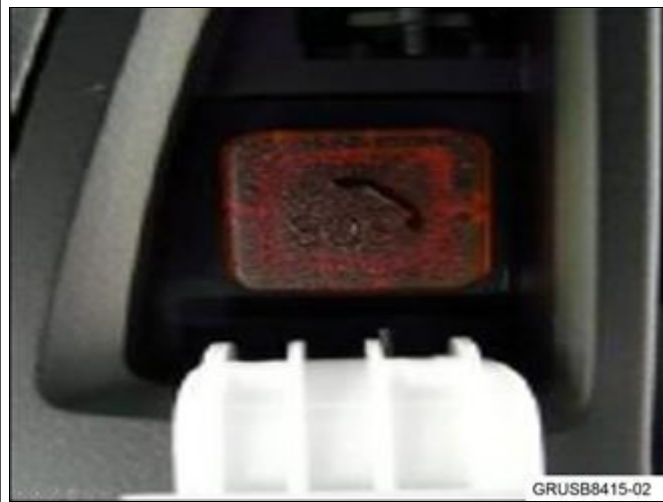
The illumination (back lighting) for the E-Call (Emergency/SOS call) button in the FZD (sunroof module) overhead console does not work.

This picture shows the E-Call button illumination (back lighting) not working.
Note: Pressing the E-Call button will start an SOS call, even though the back lighting is not working.

Missing wiring harness for the illumination of the E-Call button.

Install a retrofit harness.

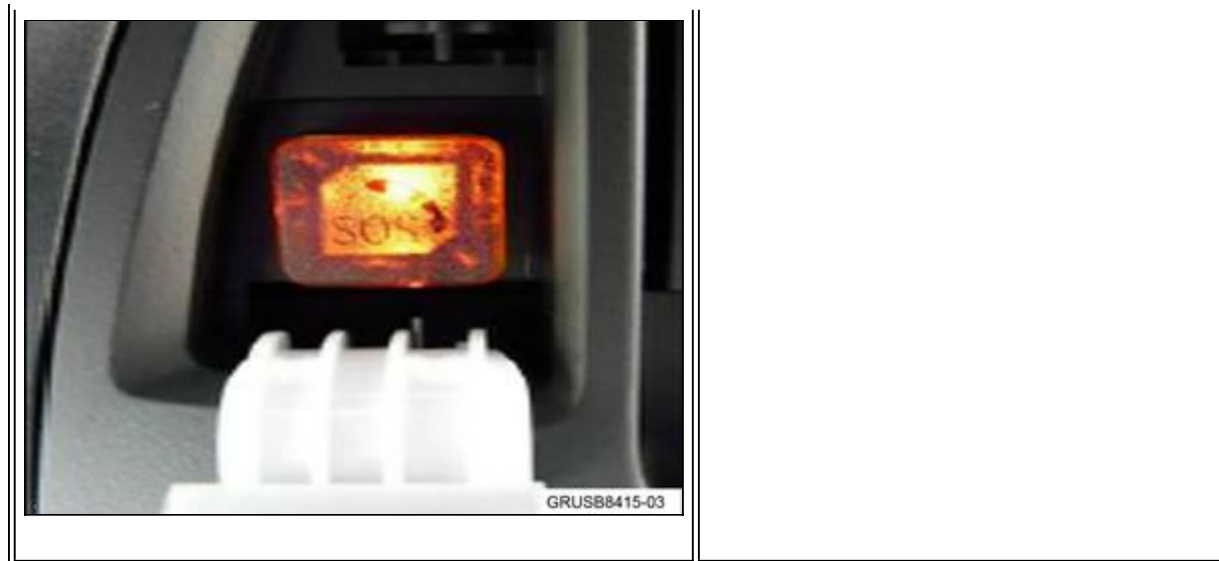
This picture shows E-Call illumination (back lighting) working.
