Service Action: Repair Roof Side Frame Paint

F82 (M4 Coupe)

Produced from January 13, 2015 to April 1, 2015

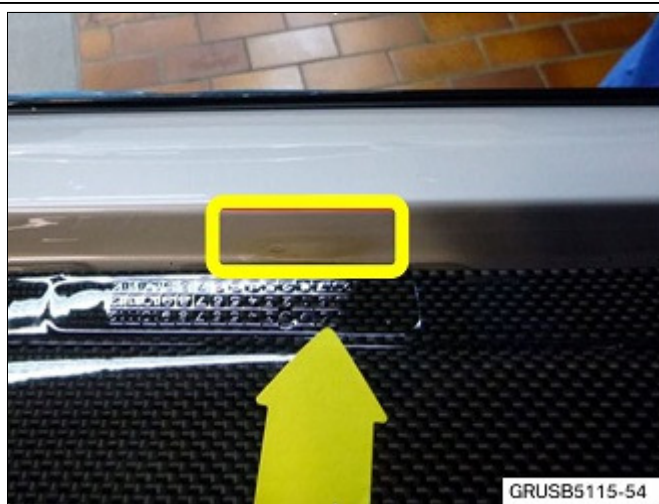
Paint on the left roof side frame may be damaged due to exposure to high heat during production.

3. The area that may be affected is approximately 3 -5 cm in size and it located on the inside edge.
