Technical Service Bulletin

| Subject: STAINS FOUND ON PAINT DURING PDI | Bulletin No.: 09-021/18 |
| | Last Issued: 10/10/2018 |

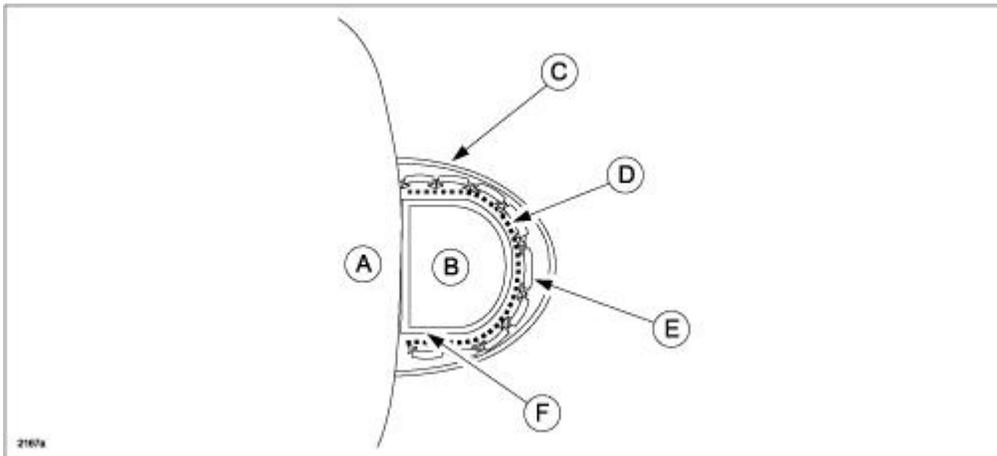
Some vehicles may experience stains appearing on the hood, roof and/or trunk of the vehicle. This concern is most likely to be found in a cold weather areas just after the RAPGARD is removed at PDI. This may be caused by moisture which has been trapped and condensed between the paint and the RAPGARD. These types of stains can be removed with a heat gun or an infrared drier.

2. Insulate all plastic and rubber parts (as shown below) using heat insulation materials (C ~ F) prior to beginning the application of heat.

- Since this repair procedure requires the use of heat from a heat gun or infrared drier, be sure to insulate all rubber or plastic parts which are easily affected by heat from near the affected stain area.
- Use extreme care to ensure the top coat surface temperature stays below 284°F (140°C).
- To protect materials inside the cabin area (i.e. carpet, seats, etc.), also place insulation over the glass as necessary.
