Field campaign

Topic	Tailgate hinge bolt (SC18/14)
Market area	Bentley: worldwide (2WBE),Hongkong-Macau (5HK)
Brand	Bentley
Transaction No.	2052498/1
Campaign number	EB11
Note	
Type	
US code

Bentayga

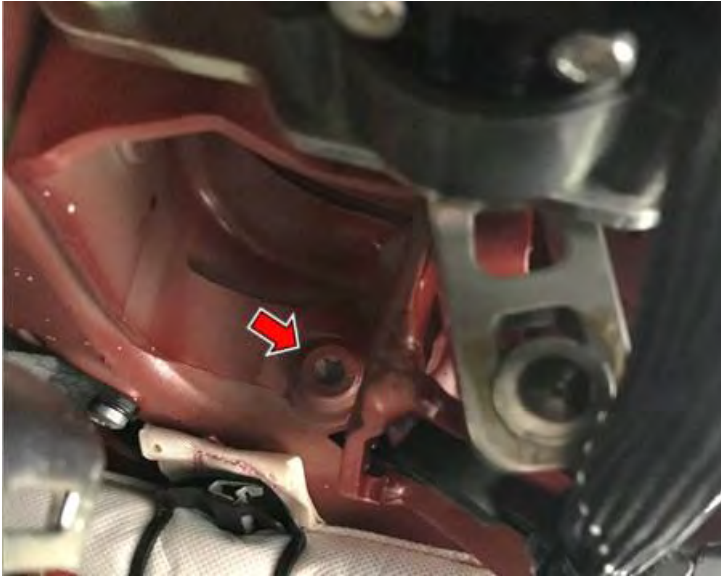
Figure 1

The tailgate hinge bolt to the body can experience torque relaxation

Replace the highlighted old bolt (*Figure 1*) with the highlighted new bolt **N 107 884 01** (*Figure 2*) on **both** tailgate hinges

20 Nm + 90°

- **The bolt must be tightened to 20Nm + 90° and no more**
The bolt must be replaced if re-torque is required
