## Technical product information

<b>Topic</b>	Rear door sunblind not retracting/opening fully
<b>Market area</b>	Bentley: worldwide (2WBE),Hongkong-Macau (5HK)
<b>Brand</b>	Bentley
<b>Transaction No.</b>	2052512/1
<b>Level</b>	EH
<b>Status</b>	Approval
<b>Release date</b>

Rear door sunblind not retracting/opening fully

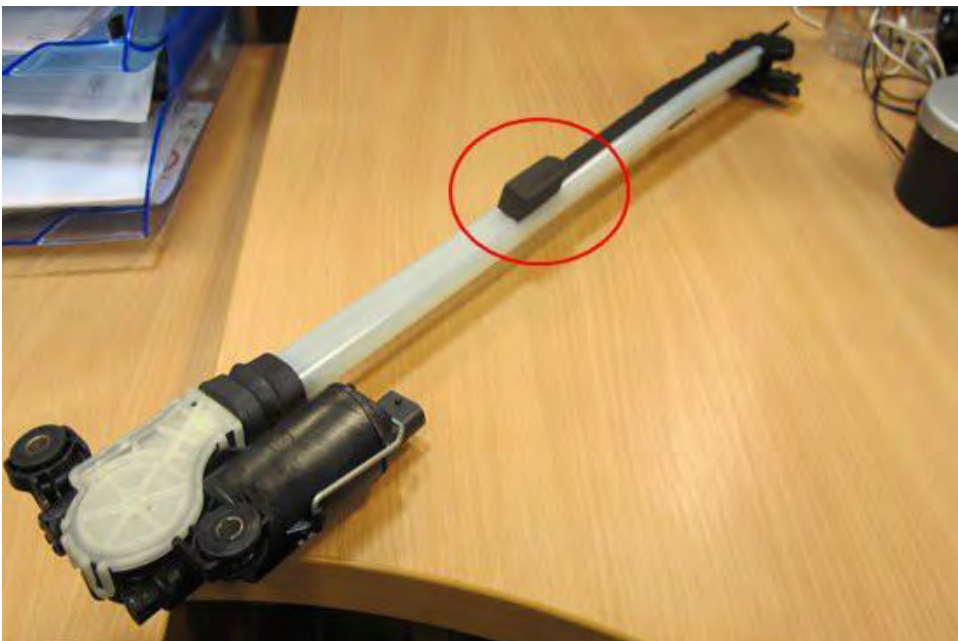
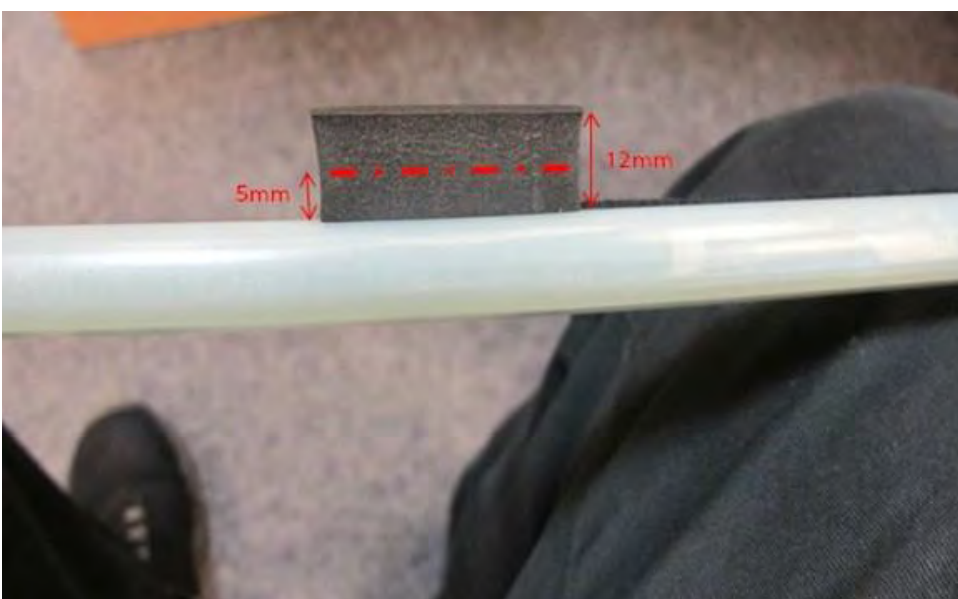
Under certain conditions the foam block on the sunblind motor can create excessive friction in the system, this can lead to difficulties in fully closing or fully opening the blind

1. Using a suitable cutting tool reduce the thickness of the foam block highlighted below from **12mm** to **5mm**
