Service Action: Repair Corrosion Protection Engine Compartment

F30 (3 Series Sedan)

F30H (ActiveHybrid 3)

Produced from June 2012 to January 2013

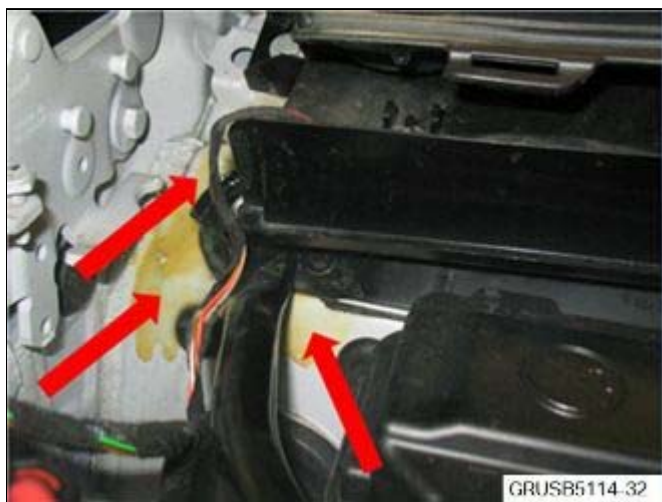
- The wax should be visible in the following areas after spraying.

- Thoroughly spray cavity wax to the bulkhead in the area of the dynamic strut, in the areas shown in the picture.

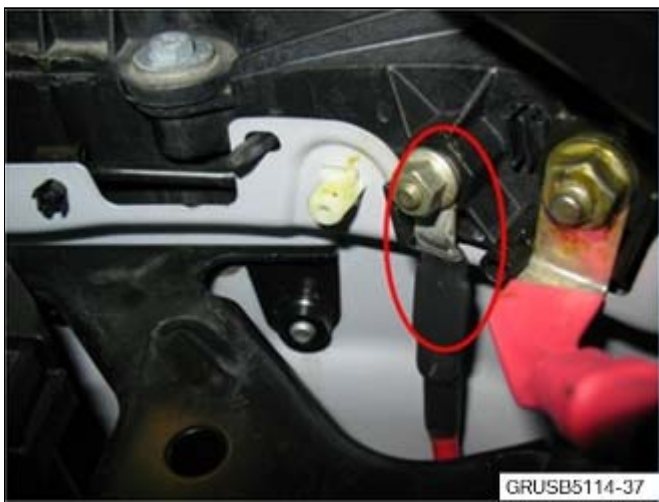
- Check that the battery positive cable installation is correct by inspecting the cable. Make sure the bend in the cable is away from the partition wall.
- This picture shows an incorrect installation of the cable: the cable might come in contact with the partition wall.
