This Service Information bulletin supersedes SI B17 01 14 **dated May 2014.**

Low Coolant Level with No Sign of External Leaks

F30 (3 Series Sedan)

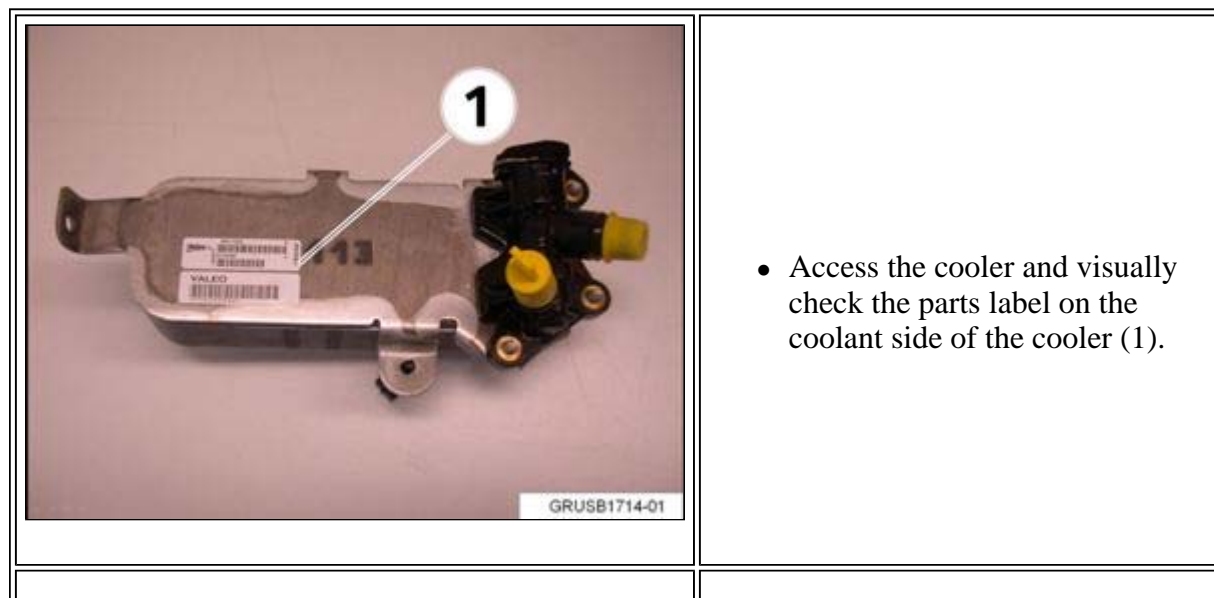
Identifying the transmission oil cooler

There is an internal failure of the automatic transmission oil cooler, allowing coolant to mix with transmission fluid. Possible faulty coolers were built between 6/6/2013 and 8/4/2013.

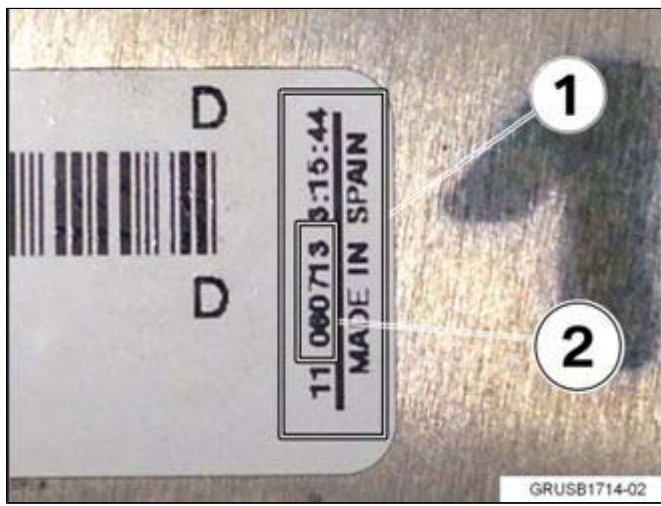
- Defective coolers are labeled “Made in Spain” (1) and the production range is 06.06.2013 to 04.08.2013 (DD/MM/YY) (2).

Once the transmission oil cooler has been determined to be faulty, the cooler and automatic transmission must be replaced. The cooler lines must be properly flushed to remove any remaining contaminants (coolant/oil mix).

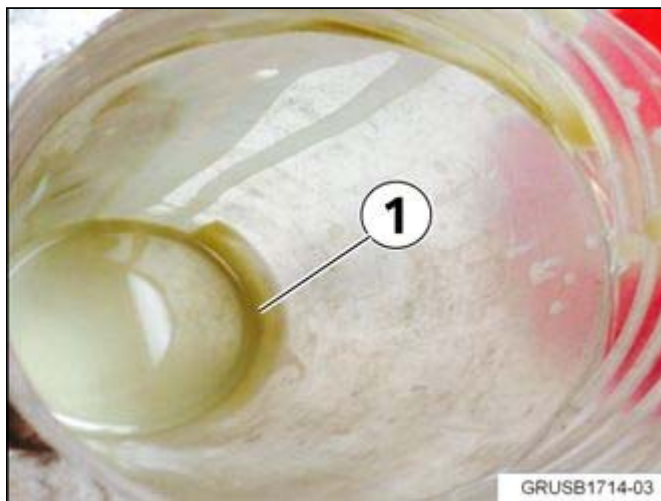
- Drain a small amount of transmission fluid (at the transmission heat exchanger) to inspect for coolant contamination. Contaminated fluid will have a milky color (1). Submit a PuMA Info Only case titled “F30 Transmission Oil Cooler” if there is any concern about the color or condition of the fluid.

NEW TC PuMA Case approval is still needed for replacement of the transmission (refer to [SI B24 05 12](#)). Provide pictures of the fluid with the Case if there is any concern about the color or condition of the fluid.
