This Service Information bulletin supersedes SI B63 08 14 **dated May 2014.**

Active Headlight Control Malfunction in Both Headlights

F30 (3 Series)

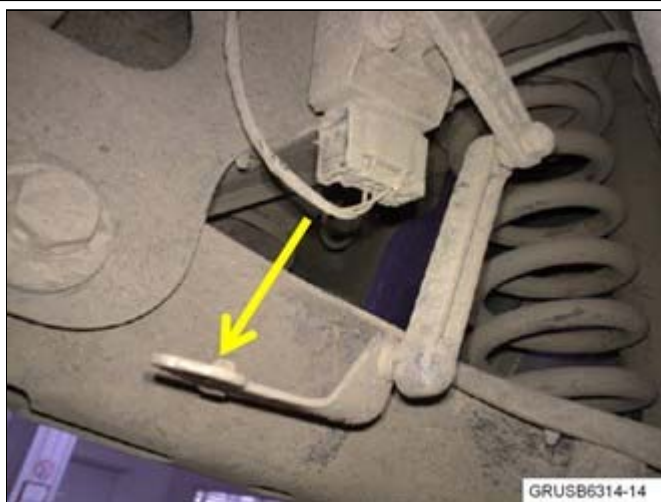
Broken mounting bolt holding on the rear height sensor bracket

1. **NEW** Inspect the rear height sensor, located in the left rear of the vehicle as shown. If the sensor bracket is hanging loose, the hex mounting bolt has broken.
