LTB01149NAS2

# TECHNICAL BULLETIN

501-14: Handles, Locks, Latches and Entry Systems

'Hood open' Warning Message Displayed On Instrument Cluster

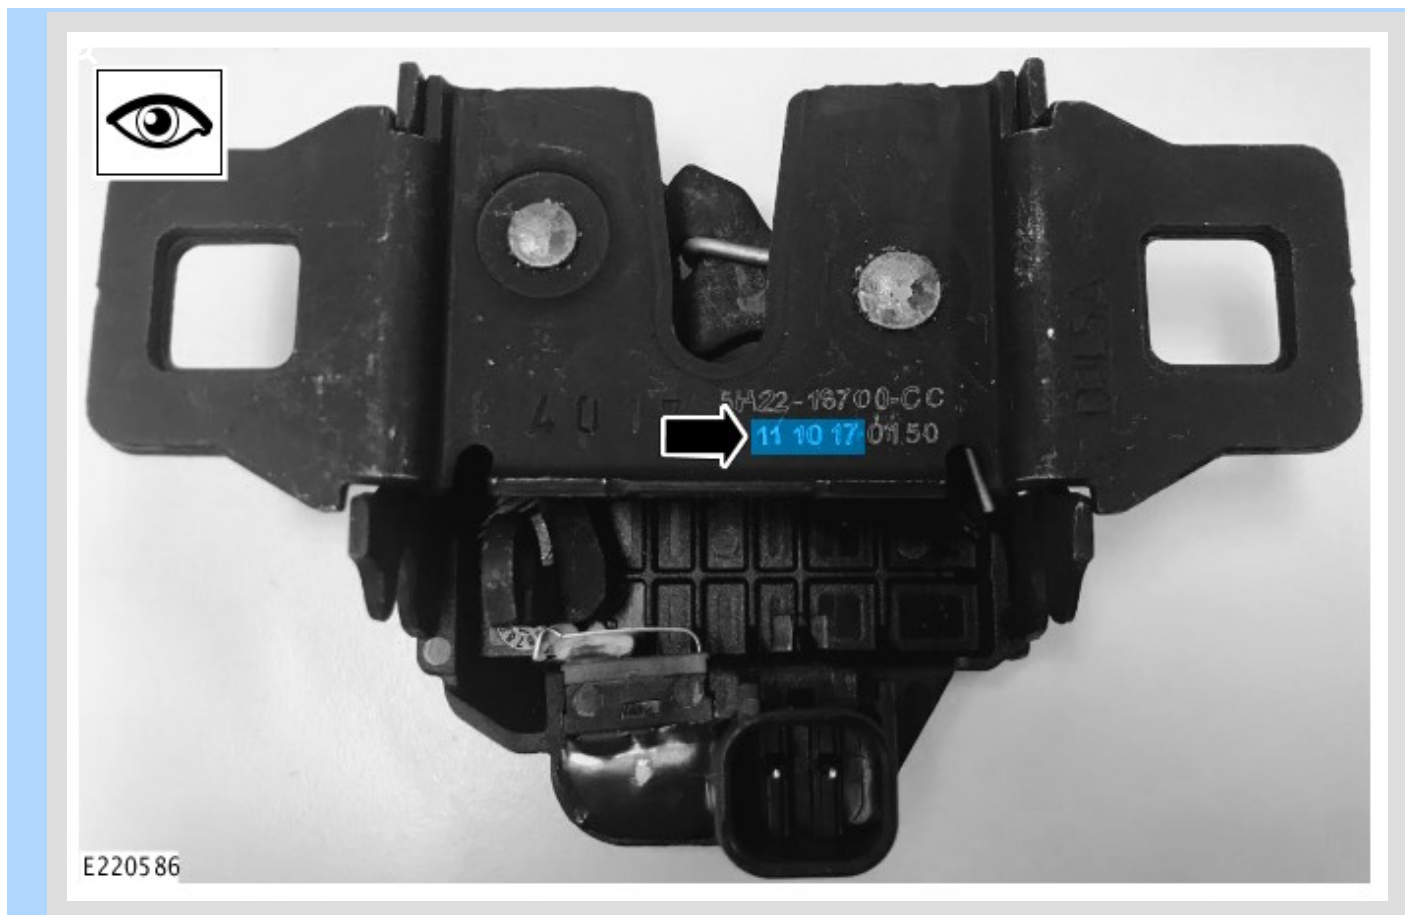
Date shown, **11 10 17** (11 October 2017), for reference only.

The date code (DD MM YY) of the new hood latch must be **27 04 18 (27 April 2018) or later.**

Replace the hood latch (see TOPIx Workshop Manual section 501-14: Handles, Locks, Latches and Entry Systems - Hood Latch).
