**NUMBER:** 19-001-15

**GROUP:** Steering

Loss Of Power Steering Assist

2015 (LA) Dodge Challenger

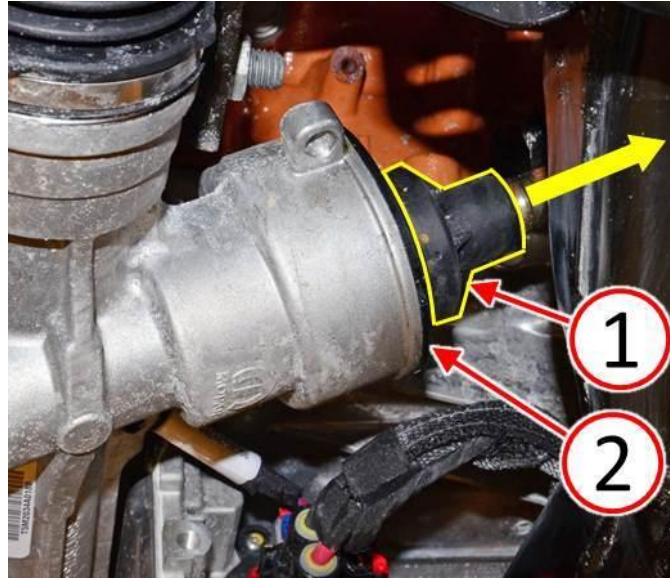
**Fig. 2 Reposition Dust Cover**

- 1 - Dust Cover
  - 2 - Pinion Cover
-

4. By hand, pull the dust cover (1) away from EPS gear pinion cover (2) and slide the dust cover along the pinion shaft until the top edge of the pinion cover is visible (Fig. 2).
