Symptom In Vehicle Interior - Warning Message "TPM Fault Service Necessary" Appears In The Instrument Cluster: Re-programming control unit for Tire Pressure Monitoring (TPM) (SY 90/18)

Vehicle Type: **Panamera (971)**
Cayenne (9YA)

Model Year: **As of 2017**

Subject: **Control unit for Tire Pressure Monitoring (TPM)**

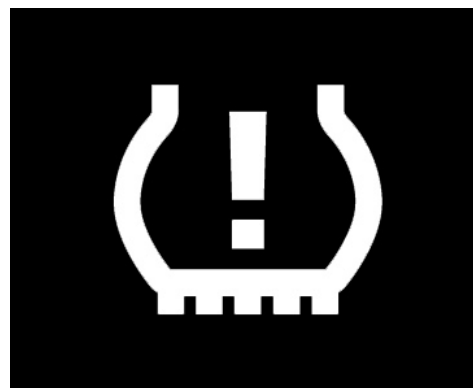
Symptom: The warning message "TPM fault Service necessary" may appear in the instrument cluster.
⇒ *TPM warning message*

TPM warning message

Cause: The warning message can appear unnecessarily in the instrument cluster due to defective control unit software.

Remedial Action: In the event of a **customer complaint and if the software version in the control unit for Tire Pressure Monitoring (TPM) is "0630"**, re-program and code the control unit for Tire Pressure Monitoring (TPM) as described below.
