NUMBER: 08-032-15 REV. A

RE9 Radio Software Enhancements

This bulletin involves updating the radio and navigation software, if required.

2013-2015	(JC)	Dodge Journey (China Only)
2013-2014	(LX)	Chrysler 300 (China Only)

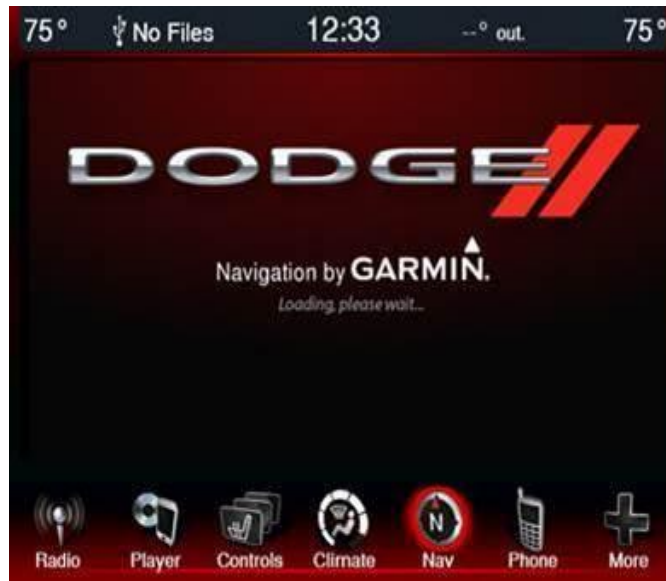
Fig. 1 System Loading Screen

1. Start the vehicle, turn the radio ON and allow it to power up.
2. Press the navigation screen button and attempt to access the navigation main menu screen.
3. Is the radio stuck on the “Loading Please Wait” screen? See (Fig. 1)
 - a. Yes >>> The radio will have to be replaced. Replace the radio using current electronic exchange center stock following normal warranty repair procedures. Refer to published service information in Tech Connect Section 08 - Electrical/8E - Electronic Control Modules/MODULE, Telematics Gateway/Removal. No further action is required, the bulletin is now complete. The replacement radio will contain the latest software update. Please use LOP **18-60-02-GS** to close out the RRT portion of this bulletin.
 - b. No >>> Proceed to [Step #4](#) and perform the software update.

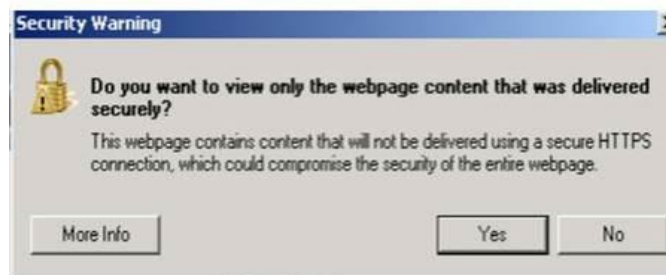
Fig. 2 Pop-up Security Message

4. Has a USB flash drive been created with the current software update?
 - a. Yes >>> Proceed to [Step #10](#).
 - b. No >>> Proceed to [Step #5](#).
5. Using Wi-tech, navigate to the Radio ECU details and record the ECU part number.
6. Go to DealerCONNECT>Service>UCONNECT Information & Utilities> Uconnect Dealer software downloads to download the files.
7. If a security message appears “Do you want to view only the webpage content that was delivered securely?” See ([Fig. 2](#)). Press **No** to continue.

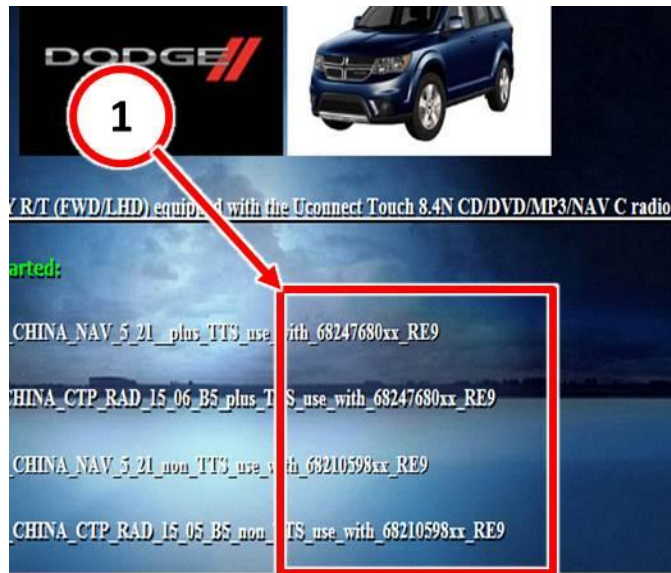
Fig. 3 Uconnect Main Portal Screen

- 8. If multiple files are available for the selected VIN, use the radio ECU part number recorded in [Step #5](#) to select the correct software packages. See ([Fig. 3](#)) and ([Fig. 4](#)) for the location of the part number information.

1 - Radio Part Number Location

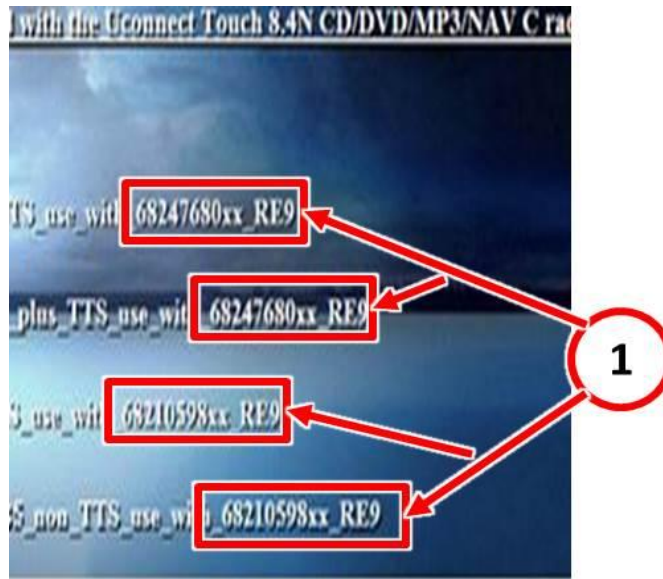
Fig. 4 Radio Software Selections

1 - Radio ECU Part Numbers

NOTE: Radio part numbers ending in XX indicate any letter combination AA through AN.

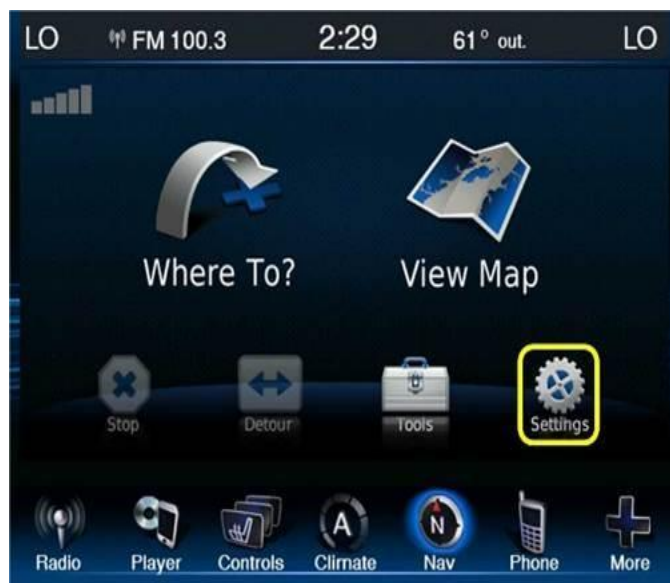
Fig. 5 Settings Icon

15. When the update is completed, the screen will read “Reflash Successful”. Touch the screen and the radio will reboot.
16. The screen will now show the current and new software levels. Verify if the new and current software levels are now the same and press no on the screen.
17. Remove the USB flash drive from the USB port and proceed to [Step #18](#)
18. From the navigation main menu screen, press the Settings screen button. See ([Fig. 5](#))

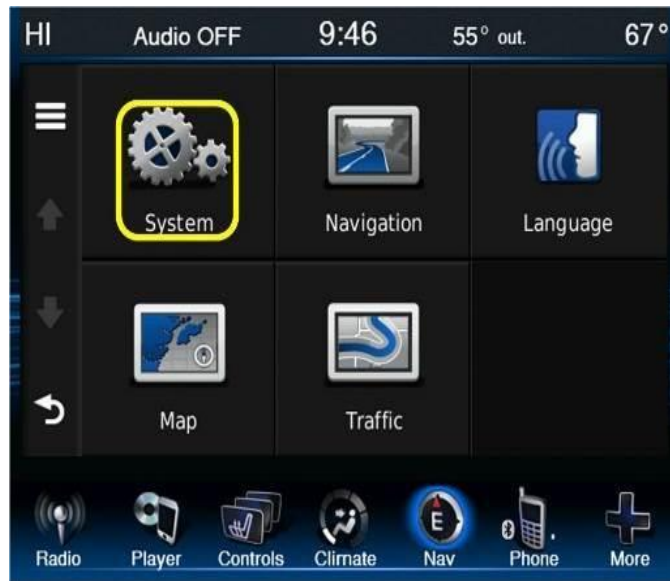
Fig. 6 System Icon

19. Press the System Icon. See ([Fig. 6](#))

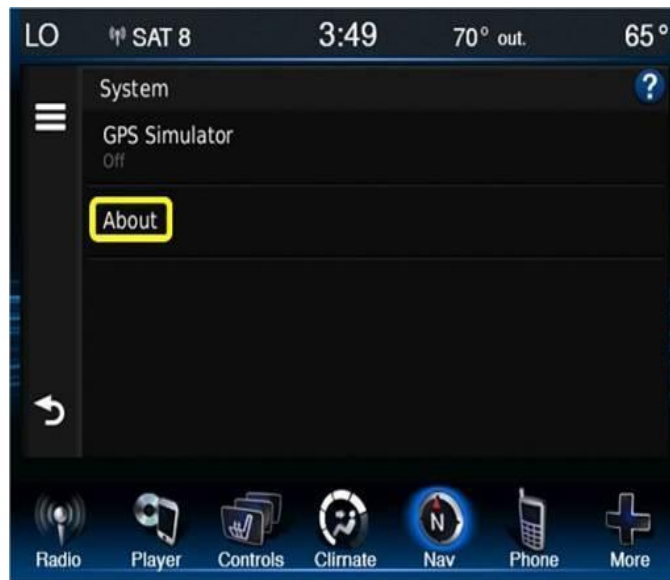
Fig. 7 About Icon

20. Press the About screen icon, see (Fig. 7), and record the software version.

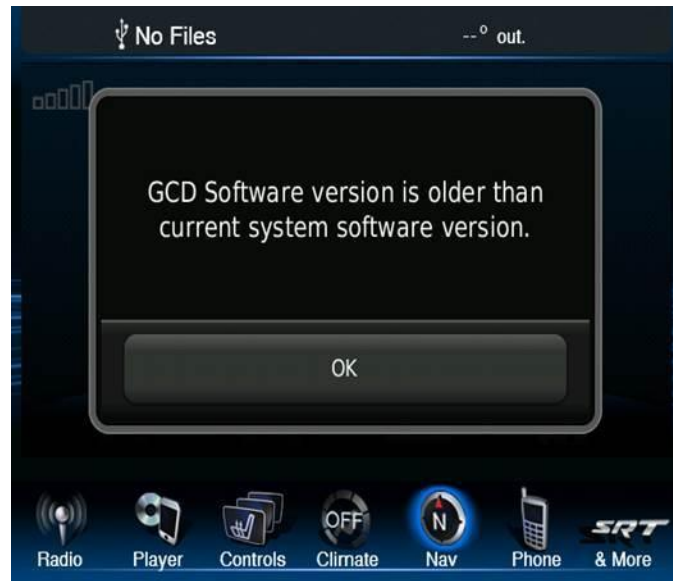
Fig. 8 Garmin Software Already Updated

24. Which screen does the radio currently display?
 - a. (Fig. 8) >>> The radio has the latest Garmin software installed. Press OK and proceed to [Step #28](#).
 - b. (Fig. 9) >>> Press Yes to continue and proceed with the Garmin software update.
25. The first step in the update is "system recover". There will be a pop up that indicates this step along with a progress bar. This will only take a few minutes.
26. This next screen will be displayed when the update is being down loaded, see (Fig. [10](#))

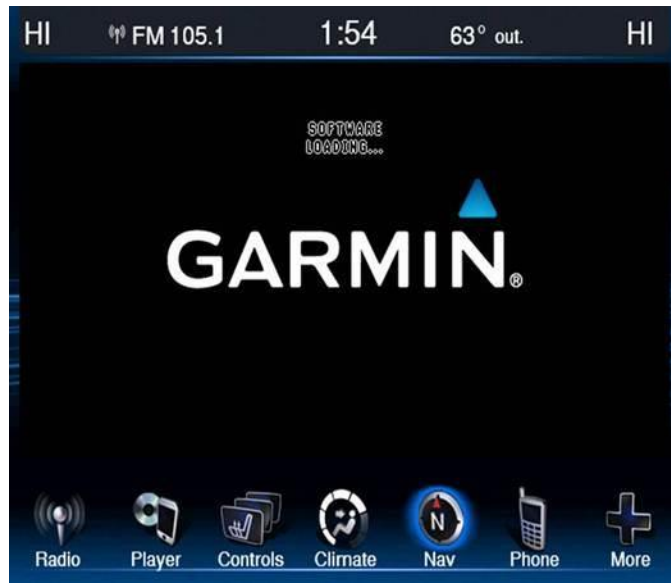
Fig. 10 Garmin software loading

CAUTION: Do not interrupt the software update process once it has begun. It may cause permanent damage to the radio which will require replacement.

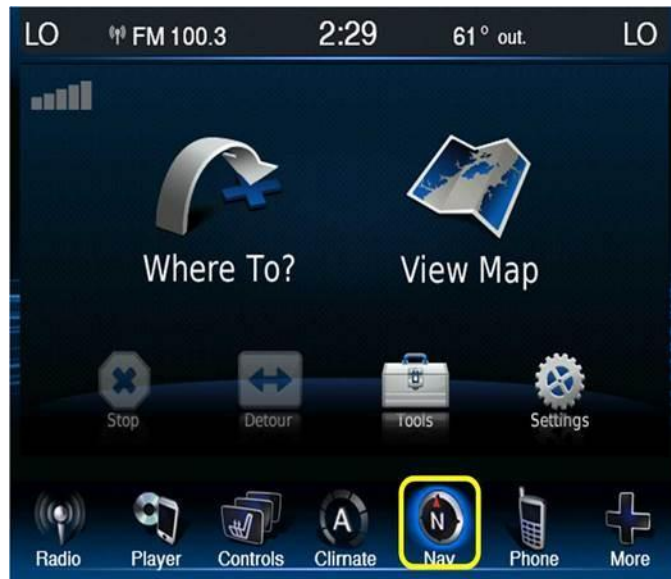
Fig. 11 Update Complete

27. When the software has completed down loading, the screen will change to the Garmin main screen, see (Fig. 11)

28. Remove the USB flash drive and cycle the key. The bulletin is now complete.
