Technical Service Bulletin

91 Concerns about GPS or satellite radio reception, repair coaxial cable

91 18 11 2045106/4 September 21, 2018. Supersedes Technical Service Bulletin Group 91 number 18-87 dated March 22, 2018 for reasons listed below.

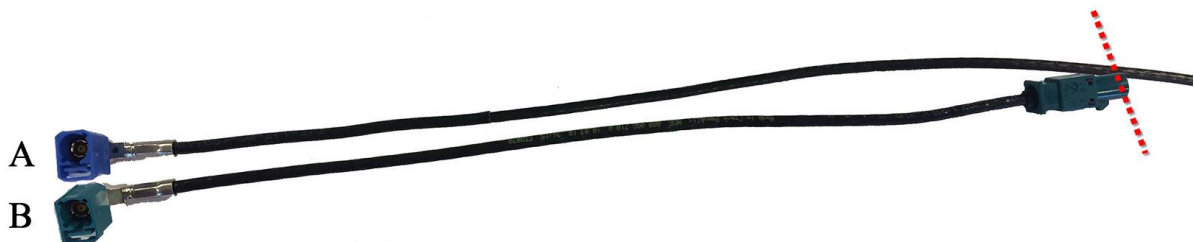
Figure 2. Measure the cut point on the vehicle's antenna coaxial wiring (A) based off the length of the replacement coaxial "Adapter Antenna Cable" (B). The removed length of cable from A should be equal to the length of cable B.

5. Follow instructions located in the repair manual to access the FAKRA connectors at the shark fin antenna. Only disconnect the FAKRA connector of the circuit associated with the customer's concern.
6. Remove a section of the vehicle's coaxial wiring for the applicable antenna circuit.
Measure the length of coaxial wiring to be removed based off the Adapter Antenna Cable you are using (Figure 2). This will ensure that the removed section is the same length as the Adapter Antenna Cable (part number 000098710A or 000098650 (Q7 only)).

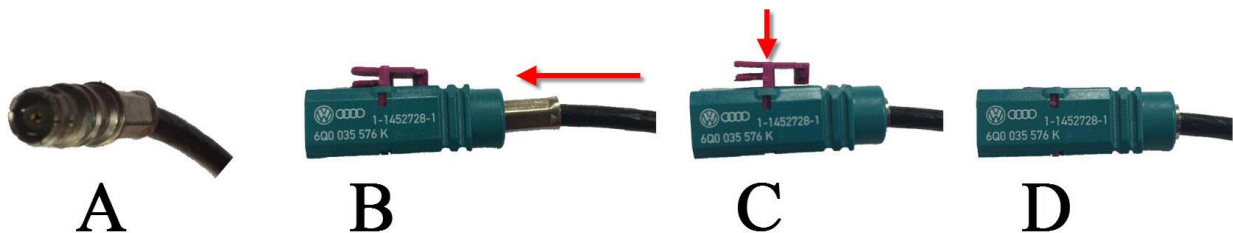
Figure 3. A: Coaxial wire with female replacement aerial connector end installed. B: Insert aerial connector end into connector housing until fully seated. C: With aerial connector fully seated in connector housing, press down on the locking tab. D: Completed assembly.

8. Install the applicable connector housing onto the aerial connector installed in the previous step. Ensure the connector is fully seated onto the coaxial connector and the locking tab is pressed all the way down (Figure 3).
