KNOCKING NOISE FROM THE ENGINE COMPARTMENT

F48 (X1)

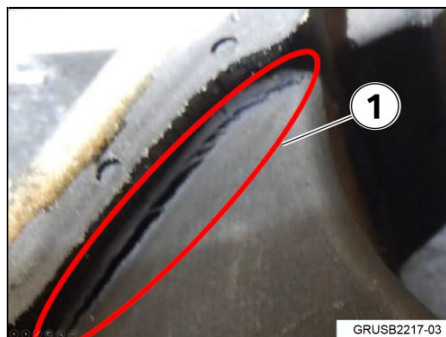
Damage to the right side engine mount. The damage may be subtle (1st picture) or obvious (2nd picture).

Is the vulcanization on the mount cracked, damaged or completely separated?

Inspect the right engine mount and replace if necessary.

YES- Replace the engine mount. Continue to step 2.
