High Battery Discharge Warning: Battery Needs Replacement

F01

F02

Produced from 9/2009 to 7/2012 with N63 engine

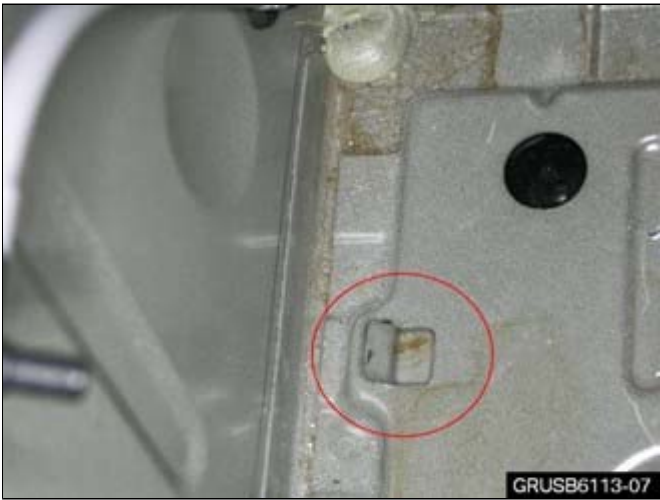
<p>GRUSB6113-07</p>	<p>Important Note: Before mounting the battery in place, bend the metal tab down flush with the battery tray. In some cases, a longer battery vent tube must also be installed in order to facilitate the larger battery.</p>
<p>NEW</p>

4. Replace the originally equipped 90 AH AGM battery with a 105 AH AGM battery. Refer to ISTA Repair Manual “61 00 ... Notes for disconnecting and connecting battery.”

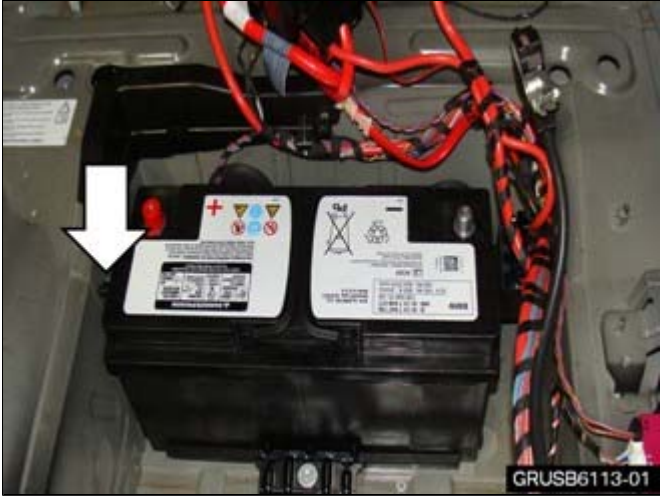
<p>GRUSB6113-01</p>	<p>Before mounting the battery in place, make sure the battery vent hose is connected as indicated by the arrow. The short end of the elbow should be connected to the battery to gain some extra clearance. Record the matrix and supplier code from the label of the battery for entry in the next step. The original battery hold-down clamp can be used with the new battery.</p>
