SI B13 04 09
Fuel Systems

May 2013
Technical Service

N54 Engine: Diagnosis of Cold Start Rough Running with Misfire Faults

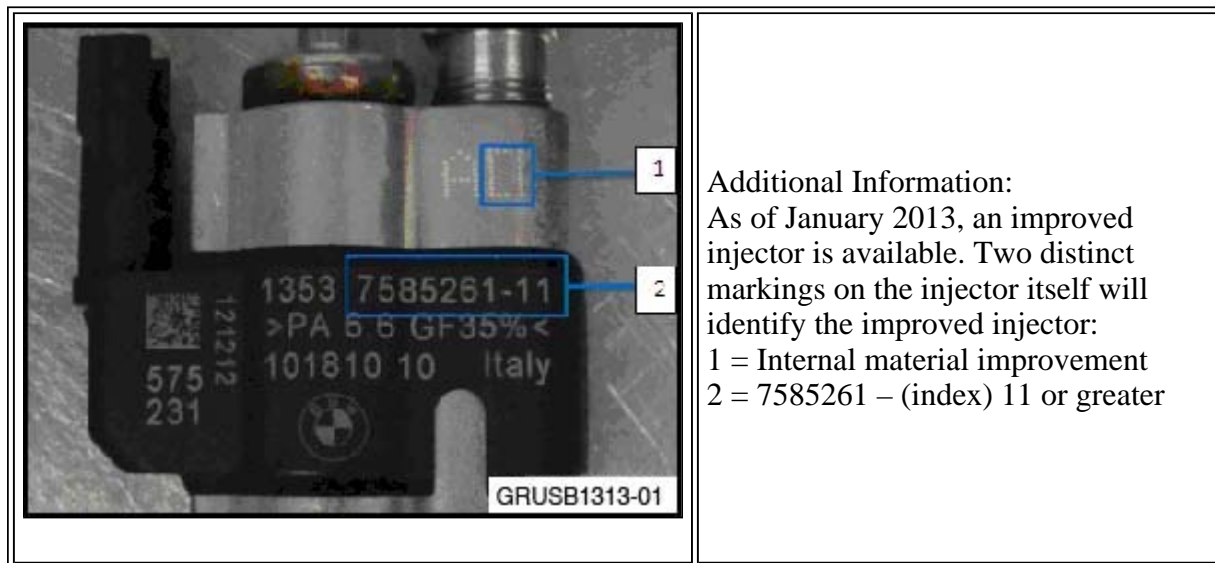
See the photo below to properly identify the index number.

IMPORTANT: Injectors with index 11 and higher have a different calibration and construction than injectors with index 10 and lower.

Due to this difference, the injectors with index 11 and higher and injectors with index 10 and lower cannot be mixed on the same engine bank (i.e., cylinders 1-3 or 4-6).

In the case of reproducible “cold start” rough engine running with corresponding misfire faults, replace all three high-pressure injectors on the bank that is faulted (1-3 or 4-6) using improved P/N 13 53 8 616 079 with index 11 or higher.

Once a bank of injectors is at index 11 or higher, the “bank set replacement” requirement no longer applies. For index 11 injector failures, only replace the failed injector.
