Technical Bulletin

Model(s)	Year(s)	Eng. Code	Trans. Code	VIN Range From	VIN Range To
Golf Sportwagen, Alltrack	2015-2018	All	All	AU_FM500001	AU_JM765566

60 18 03 October 2, 2018 **2045672** Supersedes Technical Bulletin 60-18-02 (V601802) dated February 21, 2018 to update model year applicability.

Water Leaks from the Rear of the Panoramic Sunroof

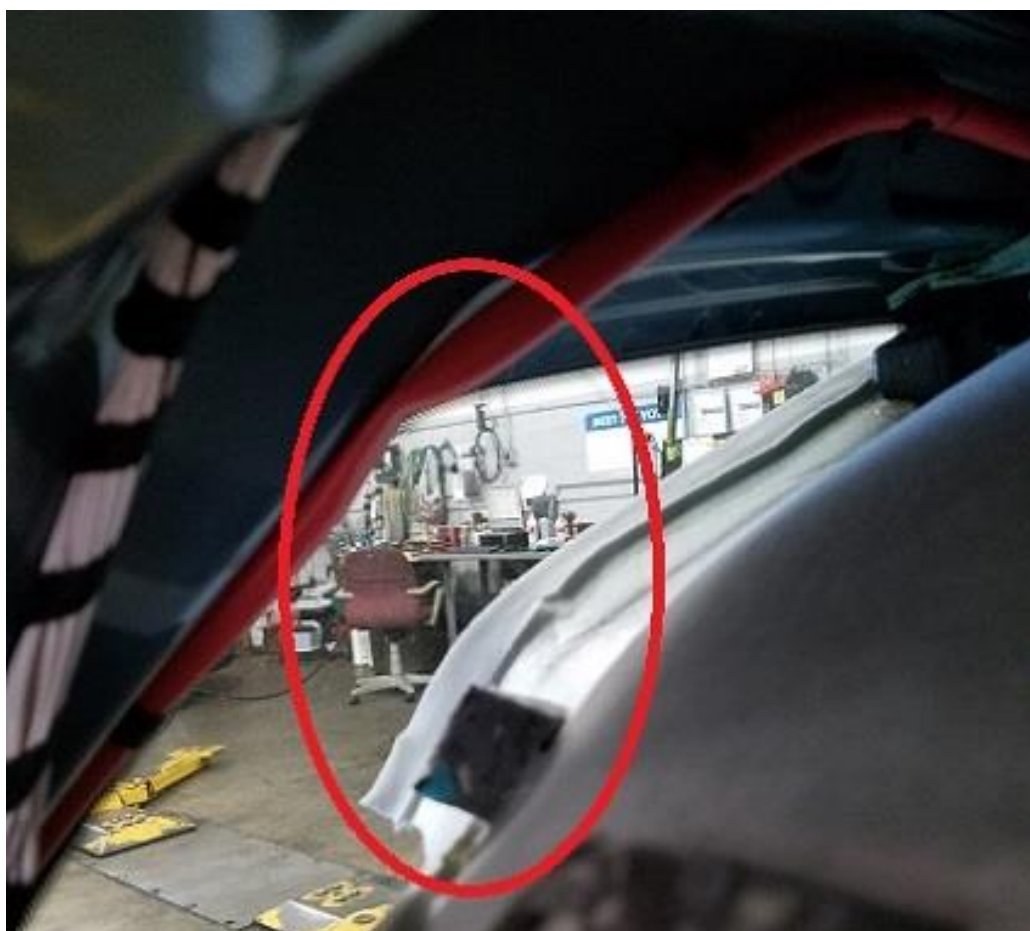
The rear sunroof drains may be pinched shut by foam blocks on the headliner, not allowing the sunroof frame to drain properly (See Figure 1).

Figure 1: Sunroof drain pinched by foam block on headliner

Incorrect assembly in production allows too much length in the sunroof drain between the second and third securing clips. This causes excess slack in the drain hose allowing the foam block to contact the hose.

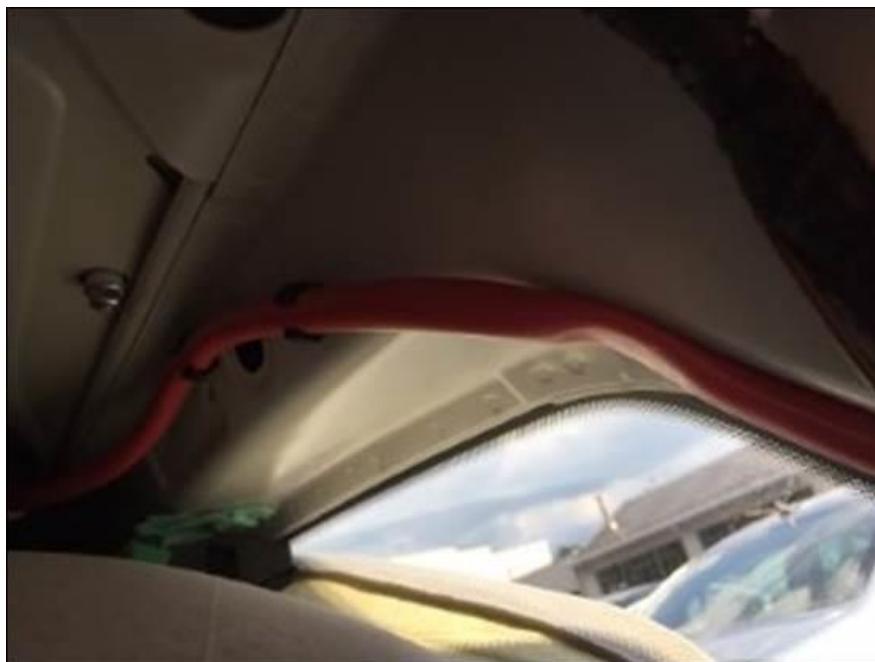
Figure 3: Impression on rear sunroof drain from contact with headliner foam block.

5. Remove the C-Pillar trim panels. See repair manual group 70 in ELSA.
6. Remove the D-Pillar trim panels. See repair manual group 70 in ELSA.
7. Loosen the rear roof grab handles from the mounts in the grab handle brackets. DO NOT completely remove. See repair manual group 68 in ELSA.
8. Remove the luggage compartment lamp. See repair group 96 in ELSA.
9. Carefully lower the rear of the headliner and inspect the rear sunroof drain hoses. The drain hoses should be replaced if they show signs of being pinched by the foam blocks on the headliner (Figure 3).

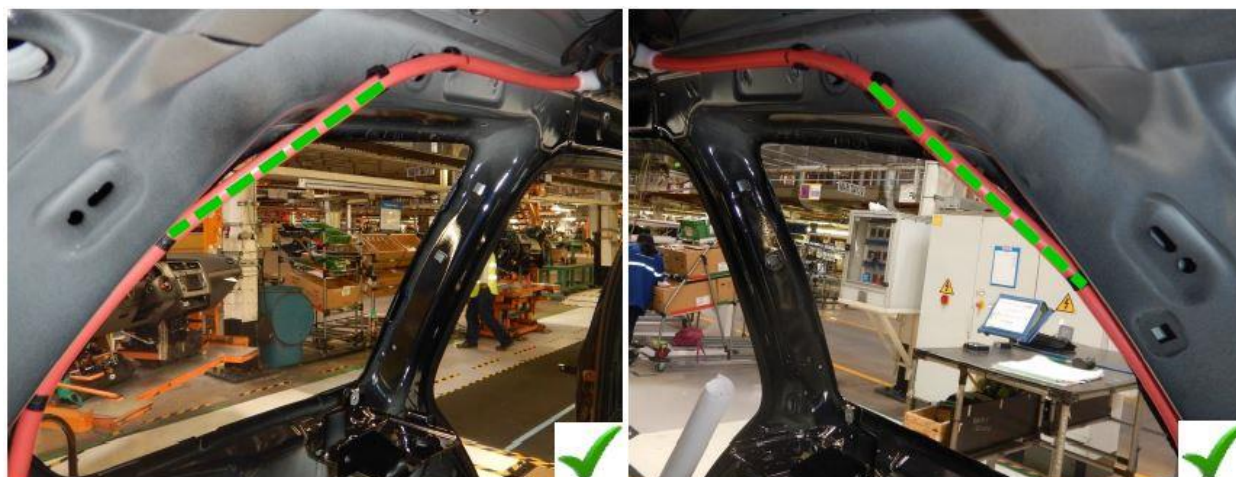
Figures 4 and 5: Correct routing of left and right rear drain hoses with no slack between the 2nd and 3rd mounting clips.

The new hoses (longer than original) should be cut to match the length of the original hoses prior to the installation. During installation of the new drain hoses, ensure the hoses are pulled taught between the 2nd and 3rd mounting clips with no excess slack in the hoses (See Figures 4 and 5).

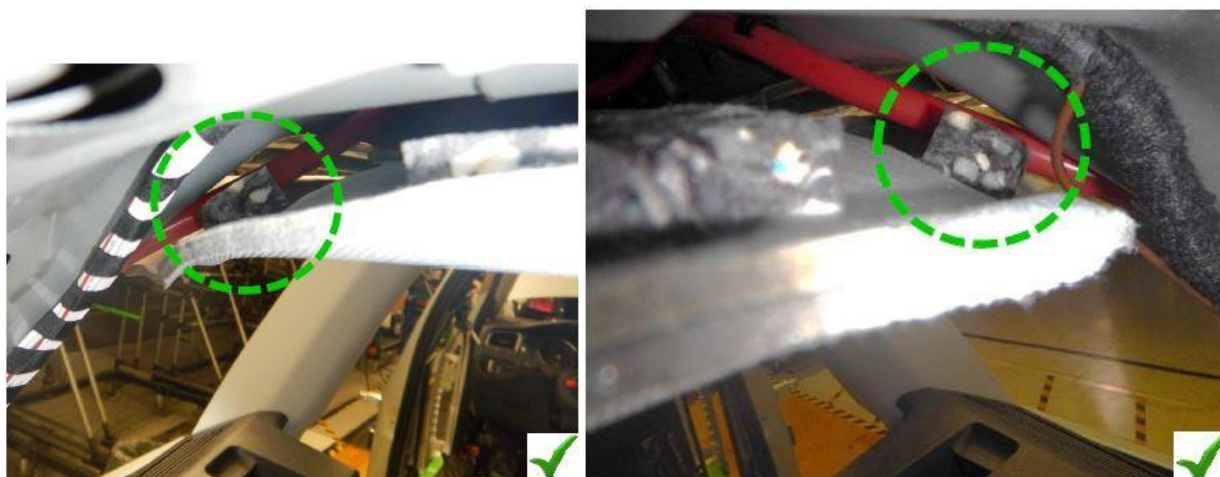
Figures 6 and 7, Rear drain hoses routed behind foam blocks on headliner.

3. Reinstall the headliner ensuring the foam blocks do not contact either of the sunroof drain hoses (See Figures 6 and 7).
