SI B11 14 18
Engine

SERVICE ACTION: N63R ENGINE – CHECK AND REPLACE OIL FEED LINES AND THE MAP THERMOSTAT ELECTRICAL CONNECTOR

This Service Action involves G12 and G30 vehicles produced from February 2017 to January 2018.

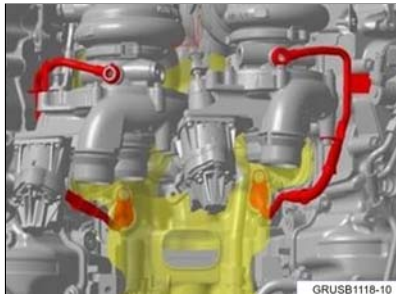
Turbocharger oil feed line overview:

The oil feed line locations are shown with red highlight

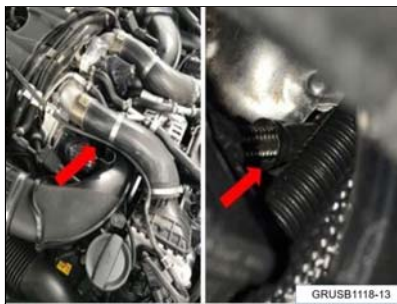
2. Check the exhaust turbocharger oil feed line on bank 1.

If the flexible section of the feed line is made of braided stainless steel (see arrows) then take no further action. **Do not replace the line.**

If the flexible section is black rubber then the oil feed line will need to be replaced.

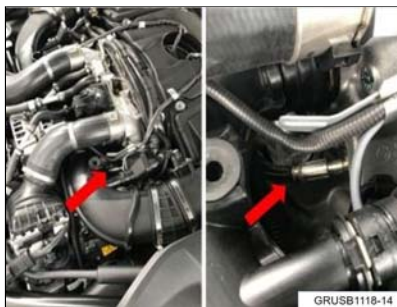
3. Check the exhaust turbocharger oil feed line on bank 2.

If the flexible section of the feed line is made of braided stainless steel (see arrows) then take no further action. **Do not replace the line.**

If the flexible section is black rubber then the oil feed line will need to be replaced.

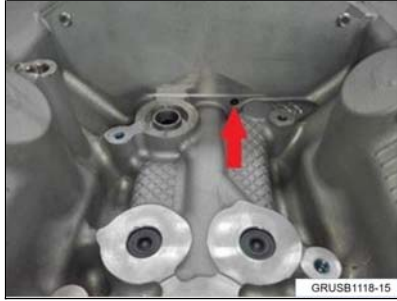
4. If the oil feed lines were actively leaking oil.

Check the engine block (V-space) for engine oil residue and clean as needed.

If there is leakage, the exhaust system, both exhaust turbochargers, the lower heat shield, the complete exhaust manifold and the oil-to-coolant heat exchanger needs to be removed to clean this area.

Wipe dry with a shop towel and rinse the residual oil with cleaner via the drain hole and flush it out (see arrow).

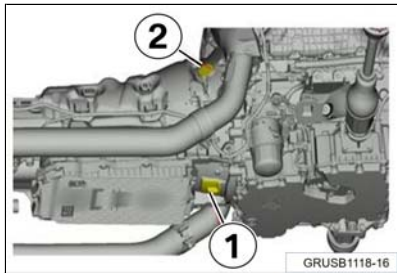
5. If the lower transmission housing also has oil residue present then it has to be cleaned via the opening (1). To do so, remove the sealing cap (1) and sealing cap (2) and flush out the excess engine oil residue. The sealing cap (2) may be located on the left or the right side of the transmission housing.

Reinstall both sealing caps when finished.

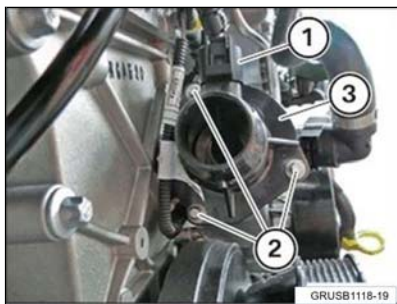
1. Locate the Map Thermostat Electrical Connector (1).

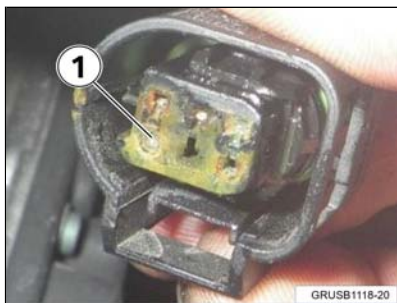
2. Remove the connector and check the pins in the connector for traces of water or corrosion.

Example: This connector is already corroded.

If the pins in the connector are corroded, the engine wiring harness and the characteristic map thermostat need to be replaced.
