This Service Information bulletin supersedes SI B11 06 13 **dated October 2013**.

**Service Action: Retrofit Bracket for EGR Cooler**

E70 (xDrive35d)

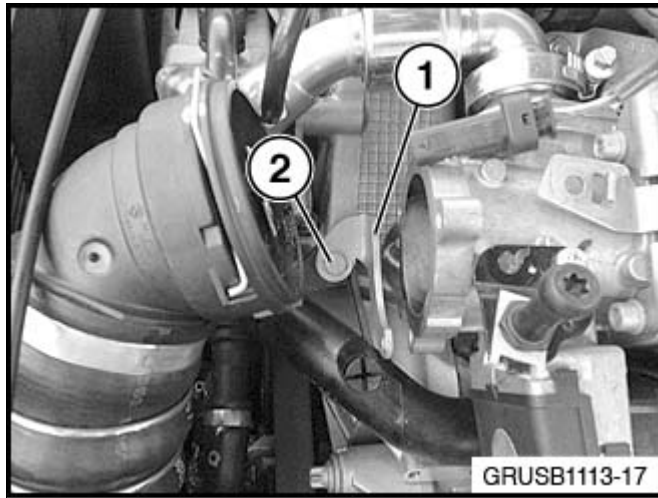
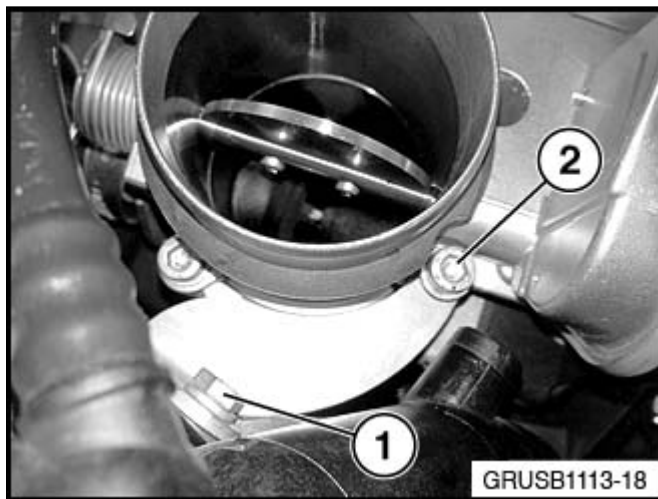
The flexible pipe on the high-pressure Exhaust Gas Recirculation (EGR) cooler may leak.

Excessive vibration and/or tension at the flexible elbow of the EGR cooler can cause it to leak.

<p>Install bracket P/N 13 54 8 576 446 (1) to the cylinder head using the bolt P/N 07 11 9 904 527 (2). Leave this bolt finger tight until after the throttle valve is reinstalled. <b>NEW</b> Note: If the EGR cooler is leaking at the flexible elbow, replacement is necessary.</p>
--	--

Reinstall the throttle valve and snug down all three throttle valve screws. Torque the two screws that are not attached to the new bracket to specification (8Nm). Tighten down the bracket bolt on the cylinder head (1) to 8Nm. Tighten the screw (2) holding the bracket to the throttle to 8 Nm.
