**SUBJECT****Noise from Steering Column Switch Cluster when Turning****MODEL**

F25

F30

F31

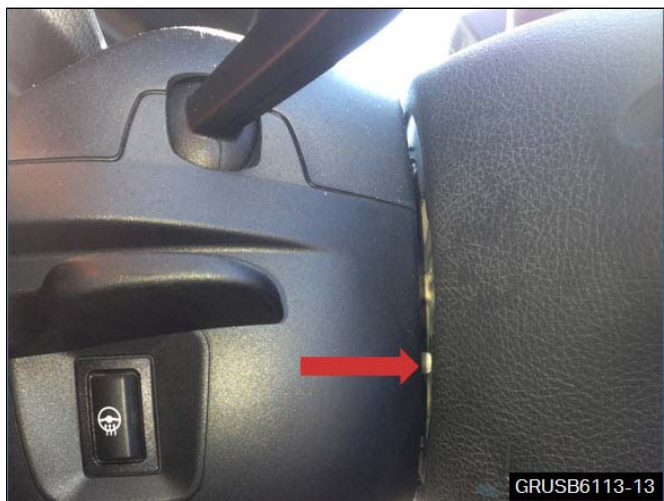
A scraping noise is heard from the SZL (Steering Column Switch Cluster) area. This occurs when turning the wheel from 30 to 60 degrees.

The unlocking pin in the SZL makes contact with the steering wheel.

1. In the picture to the left, the white locking pin can be seen (from the driver's side) looking between the steering wheel and the column.
