Service Action: Replace the Left and Right Fuel Level Sensor

E70 with N52K, N62TU and S63 engines

E71 with N54, N63 and S63 engines

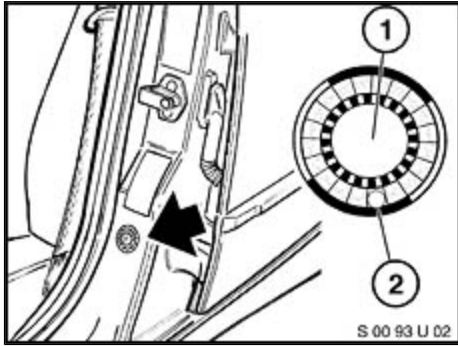
This Service Action has been assigned code number **633**. After the vehicle has been checked and/or corrected, obtain a label (SD 92-417) and:

- A. Emboss your BMW center warranty number in the middle of the label (1);
- B. Punch out code number **633** (2), printed on the label; and
- C. Affix the label to the B-pillar as shown.
