Becker MAP PILOT Gen. 3: Is not recognized, fails to boot up or hangs while booting, message "No navigation module connected" or the Becker logo appears continuously or intermittently in the display

Topic number	LI82.85-N-067956
Version	1
Function group	82.85 Navigation and Communication system (CNS, ICS, COMAND, FleetBoard)
Date	03-28-2018
Validity	Model 447.6/7 with code E1N (Becker MAP PILOT) Model 906 with production date as of 04/2014 with code E1N (Becker MAP PILOT)
Reason for change	Distributor corrected
Reason for block

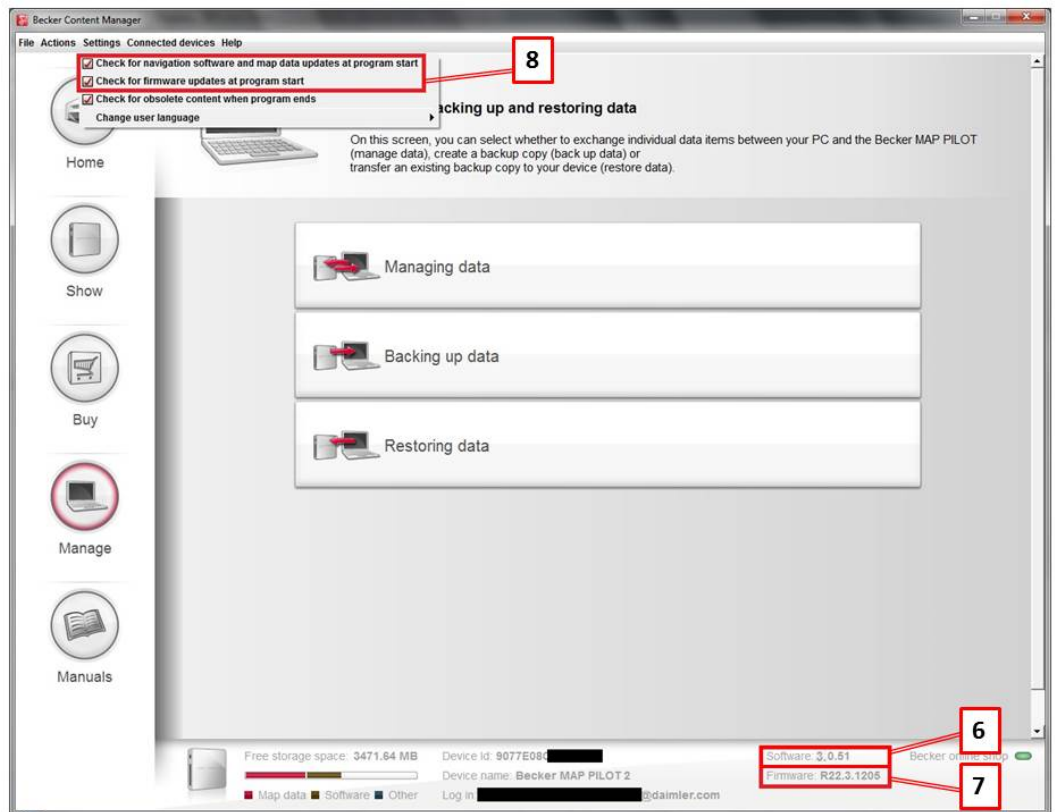
04.jpg:

Attachments	
File	Description
02.jpg	Control unit log NAV - Navigation module (English).
04.jpg	Necessary settings in Becker Content Manager and version information on connected Becker MAP PILOT (English).

- Use the Becker Content Manager to update the firmware (7) to Version " R23.x" (available since approx. 12/2015) or higher.

- Use Becker Content Manager to update navigation software (PND software) (6) to Version 3.0.10 (available since middle of 08/2014), or higher.
