# Technical Service Bulletin

## 40 Rumbling/creaking noises from front of vehicle while driving

40 18 84 2048266/4 August 9, 2018. Supersedes Technical Service Bulletin Group 40 number 18-83 dated July 30, 2018 for reasons listed below.

Model(s)	Year	VIN Range	Vehicle-Specific Equipment
Q7	2017 - 2018	All	Not Applicable
A6, A7, and A8	2015 - 2018	All	Not Applicable

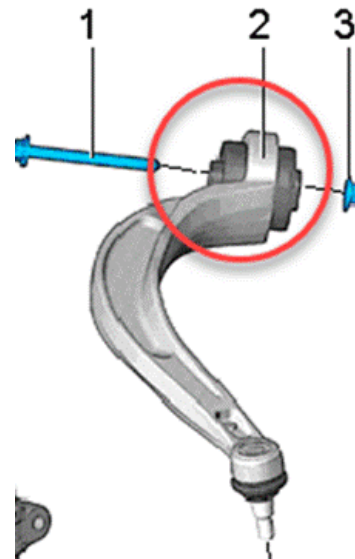
*Figure 1. Hydro-bushing.*

The noises can be generated on the lower left control arm in the area of the hydro-bushing.

Modified hydro-bushing in control arm link (Figure 1):

- A6/A7 - 4G4HN011283 on 06/21/2016, part number 4G0407183B
- A8 - 4H7HN000731 on 06/01/2016, part number 4H0407183C
- Q7 - 4M2GD063812 on 04/29/2016, part number 4M0407183B

Check the lower guide link of the front axle as it may be the source of the noises. If necessary, replace the hydro-bushing on the guide link.
