Technical Information Bulletin

34-070

34 – Wiring and Lighting

DAVIE4 Unable to Update VECU Software

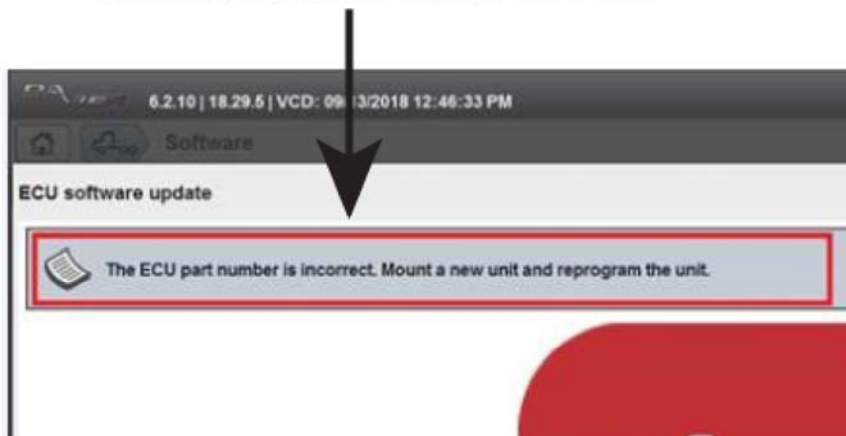
Received error from DAVIE4

- If DAVIE4 displays the following message when attempting to update the VECU software, continue with this procedure to confirm the message is caused by the missing hardware part numbers.

NOTE
DO NOT replace the ECU as the below error message directs; rather, continue on with this procedure.

5. Contact the Vehicle Support Center via a SupportLink case for the interim DAVIE4 patch. Case submission requires attaching a screenshot of the VECU properties that shows the ECU hardware number in addition to a log file and other case submission requirements.
6. The patch will be supplied via SupportLink. Download the entire folder to the local DAVIE computer.
7. Open the folder and then double click on the ApplyPatch.bat file to install the patch.
8. Restart DAVIE4.
9. Update the VECU software.

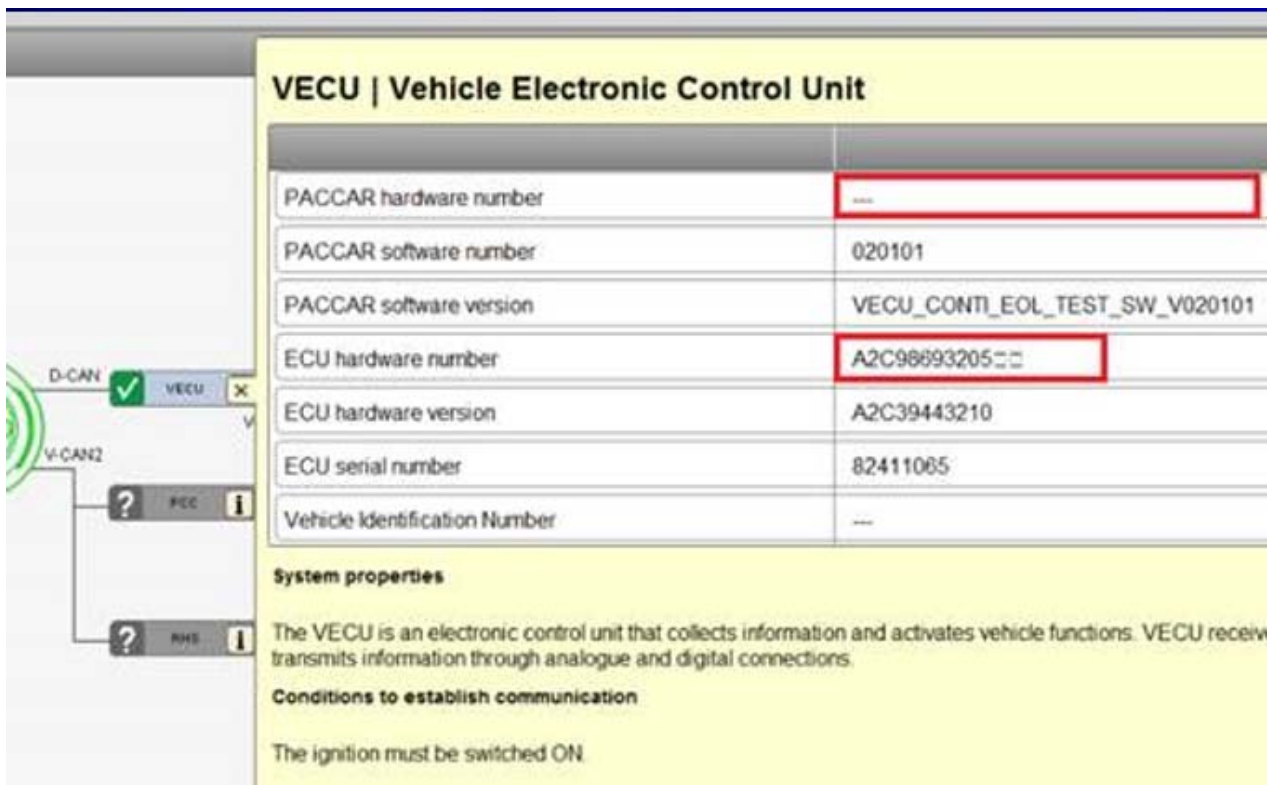
- The patch is required when:
 - There is no PACCAR hardware number shown.

AND

- The ECU hardware number is missing the last 2 digits. The last 2 digits will display "X X".
